FEDERAL EMERGENCY MANAGEMENT AGENCY

# *Above the Flood:* **ELEVATING YOUR FLOODPRONE HOUSE**

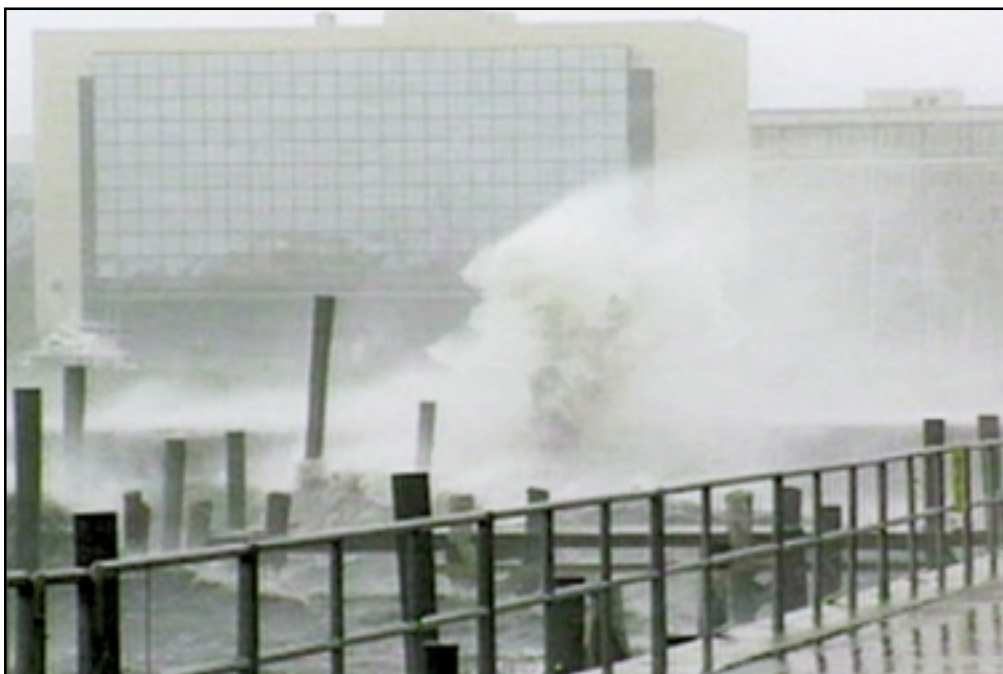
**Figure 2**

Damage to houses and other buildings was severe.

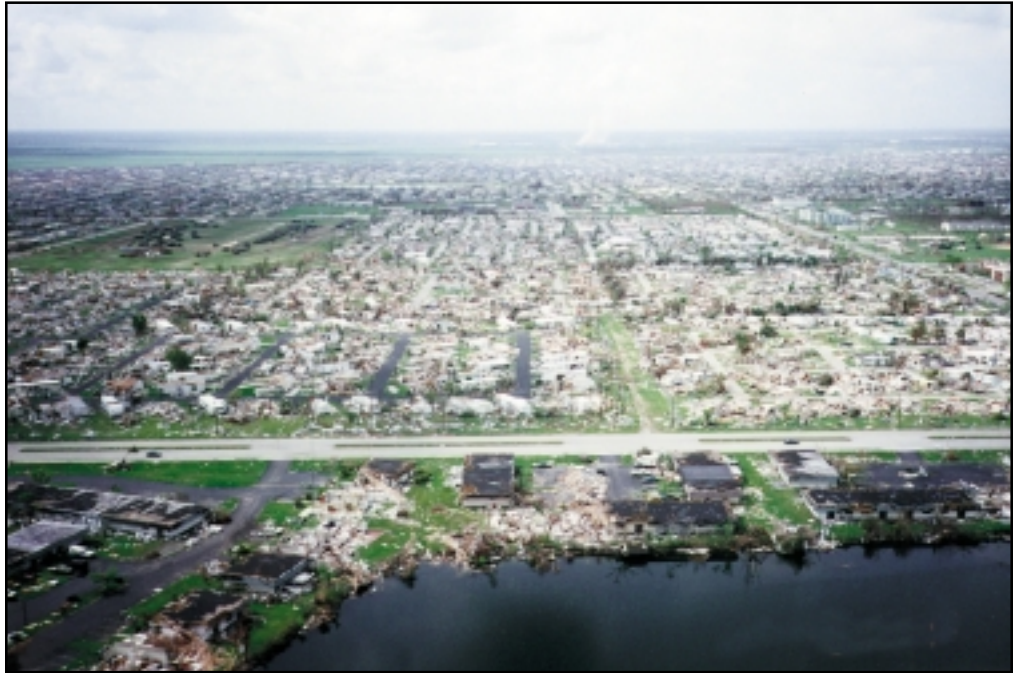
**Figure 3**

Wind damage.

The widespread destruction caused by Andrew was due primarily to high winds (Figure 3). However, flood waters contributed to the damage in low-lying coastal areas of central and southern Miami-Dade County (Figure 4).

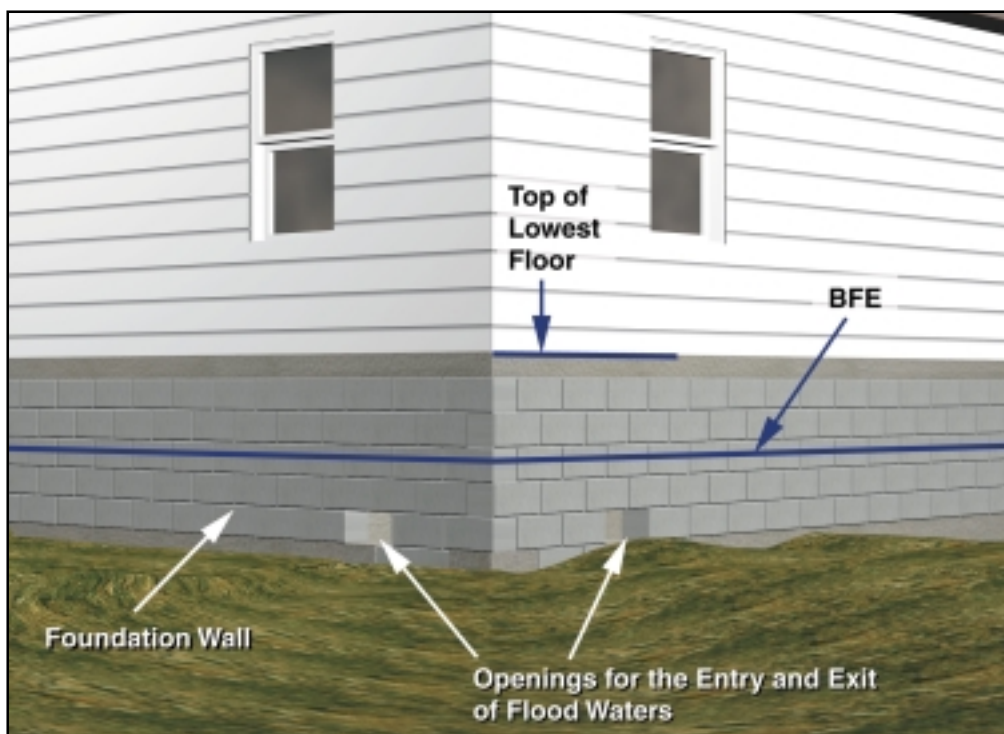
**Figure 6**

In a new, substantially improved, or substantially damaged building in an A zone, the elevation of the lowest floor must be at or above the BFE.

In A zones, where flood hazards are less severe, buildings may be elevated either on an open foundation or on continuous foundation walls below the BFE (Figure 6). Regardless of the type of foundation used, A-zone buildings must be elevated so that the **lowest floor** is at or above the BFE, as shown in Figure 6. If continuous walls are used below the BFE, they must be equipped with openings that allow flood waters to flow into and out of the area enclosed by the walls (Figure 6). Allowing the entry and exit of flood waters ensures that water pressures will be the same on both sides of the walls and reduces the likelihood that water pressure will cause the walls to fail.

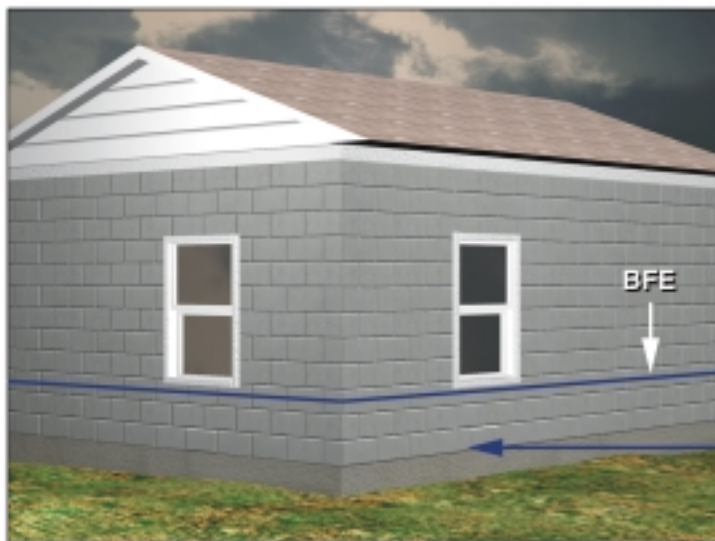
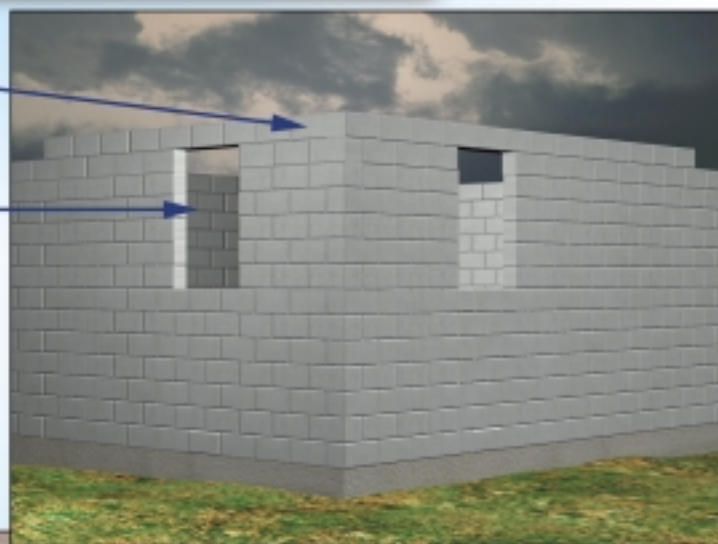
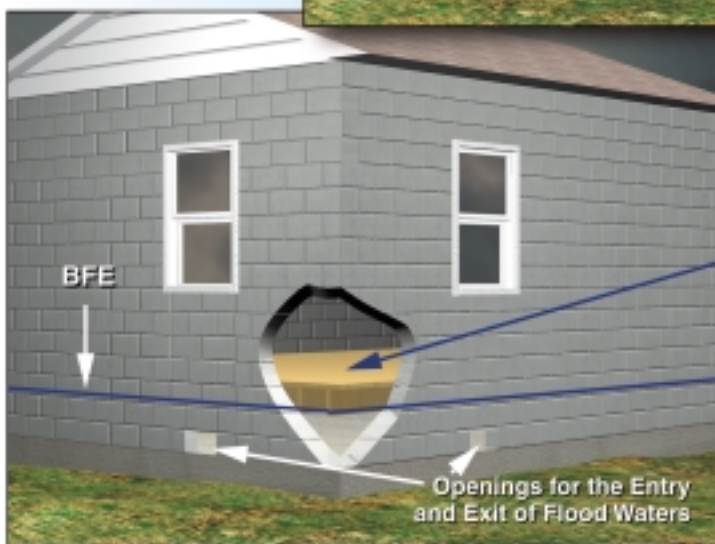
Technique 1 –  
Extend the walls of  
the house upward and  
raise the lowest floor.

House at the  
time Hurricane  
Andrew struck

Original Level  
of the Lowest  
Floor

Extended Walls

Raised Window  
Opening

Substantially damaged house  
undergoing repairs that will bring it into  
compliance with Miami-Dade County  
floodplain management requirements

New,  
Raised Floor

House after  
completion of  
repairs

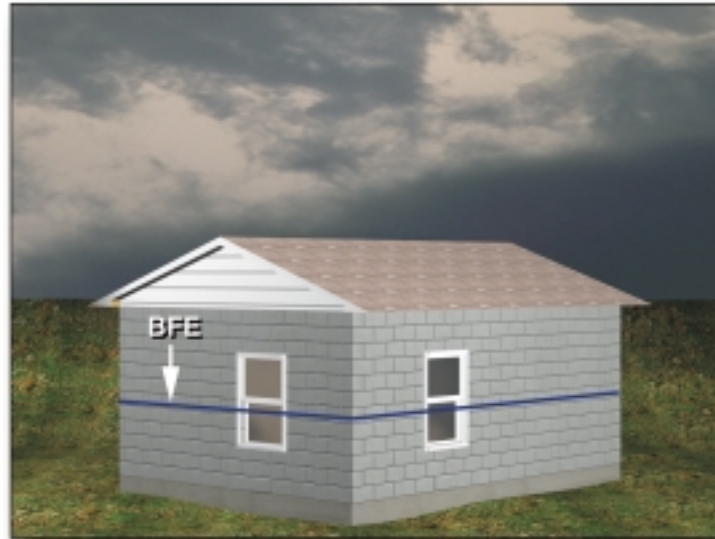
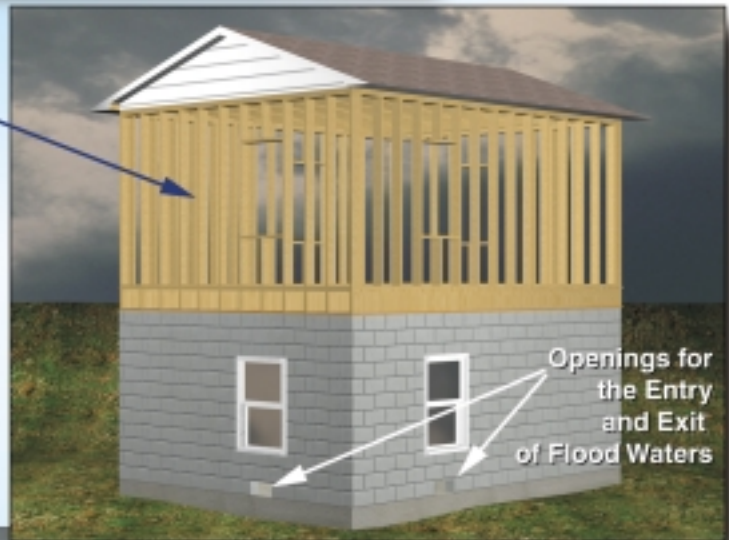
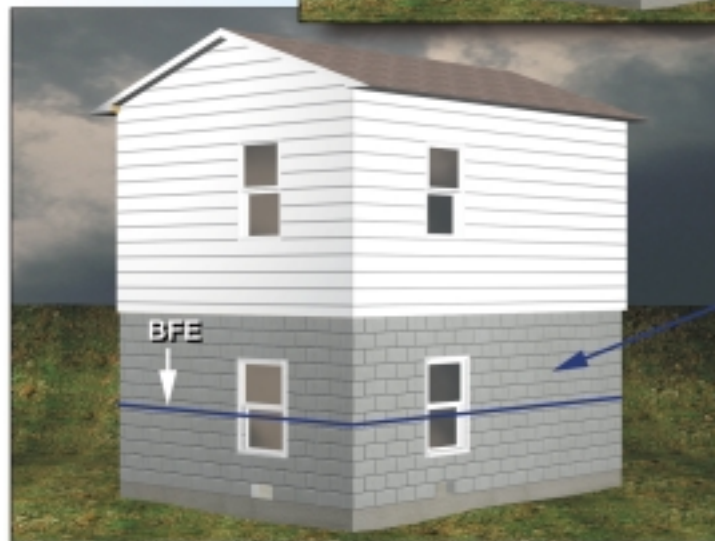
Technique 2 –  
Convert the existing  
lower area of the  
house to non-  
habitable space and  
build a new second  
story for living space.

House at the  
time Hurricane  
Andrew struck

New Second  
Story Above  
BFE

Substantially damaged house  
undergoing repairs that will bring it into  
compliance with Miami-Dade County  
floodplain management requirements

House after  
completion of  
repairs

Lower Area  
Converted to  
Non-Habitable  
Space for  
Storage,  
Parking, or  
Building  
Access

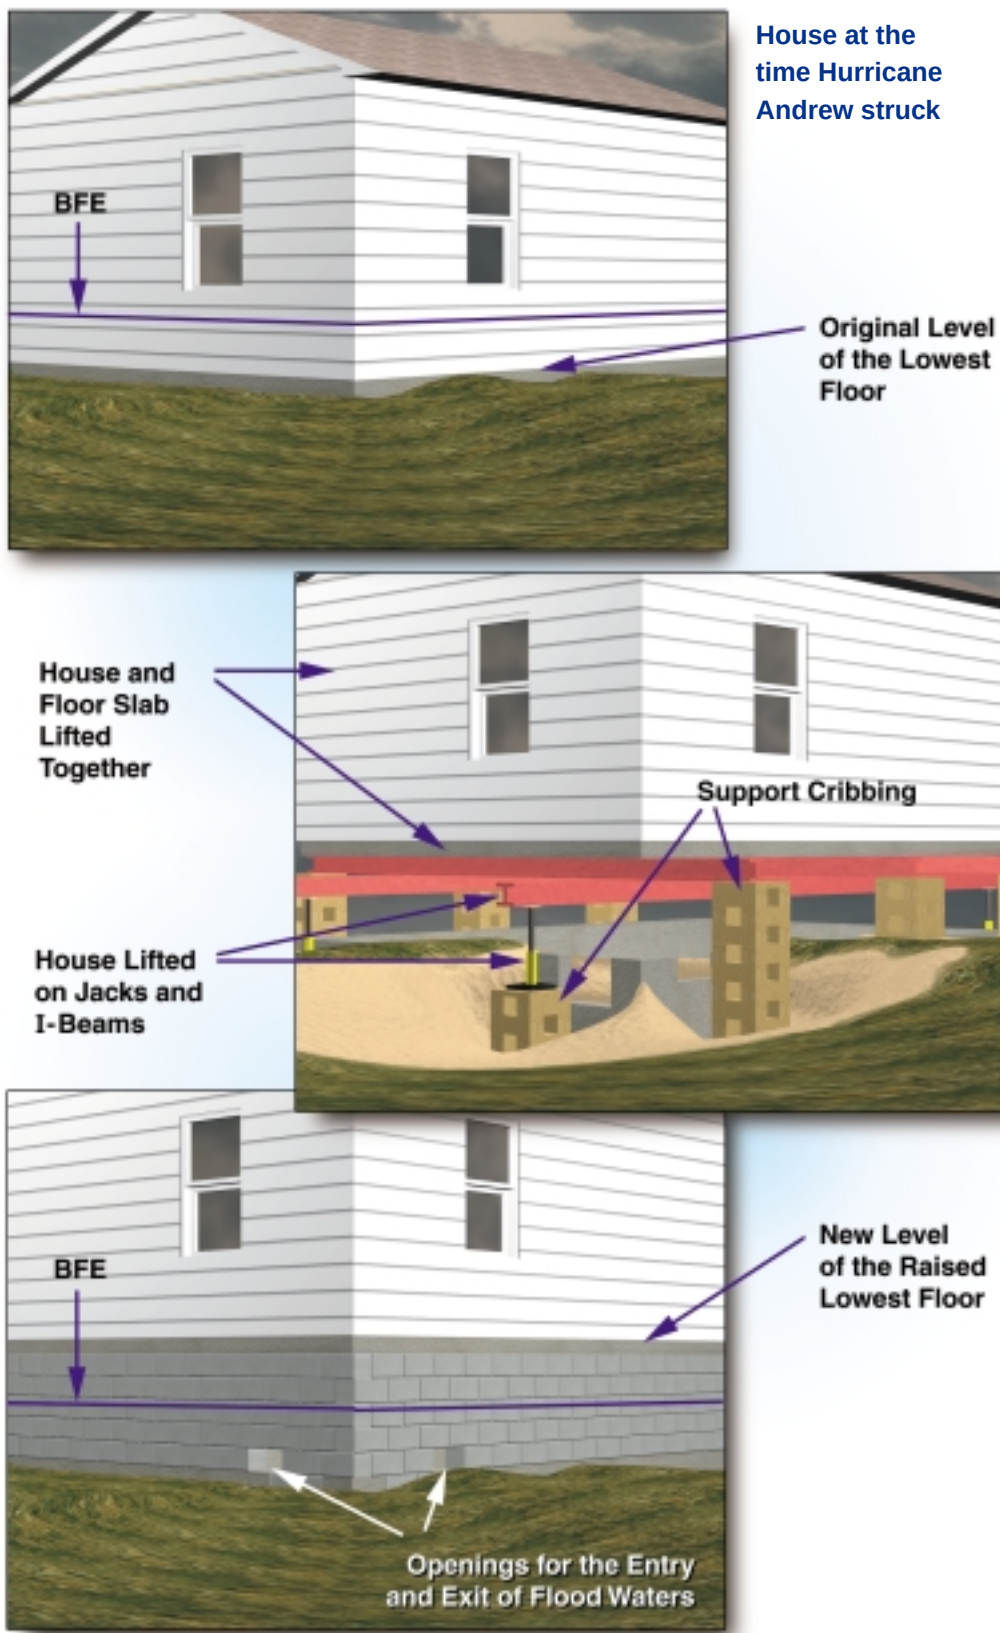
**Figure 9**

Technique 3 –  
Lift the entire house,  
with the floor slab  
attached, and build a  
new foundation to  
elevate the house.

Substantially  
damaged house  
undergoing repairs  
that will bring it into  
compliance with  
Miami-Dade County  
floodplain  
management  
requirements

House after  
completion of  
repairs

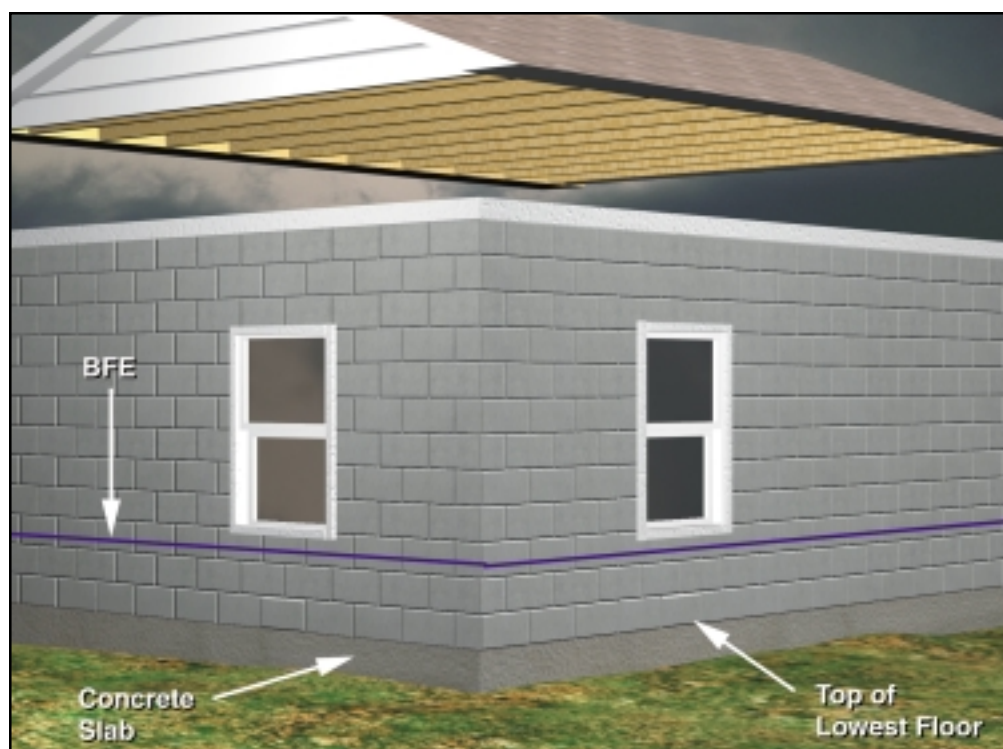
**Figure 10**  
The first step in Technique 1 is removing the roof.

Technique 1 is appropriate for houses with concrete or masonry walls, but not for houses with other types of walls, such as those framed with wood studs, which would be more vulnerable to flood damage. This technique is usually appropriate when the depth of the base flood at the house is no more than 4 or 5 feet above grade. The elevation process begins with the temporary removal of the roof and roof framing, in a single piece if possible (Figure 10). This is commonly done with a crane. The roof is then stored on site so that it can be reinstalled later. The next step is to remove the windows and doors.

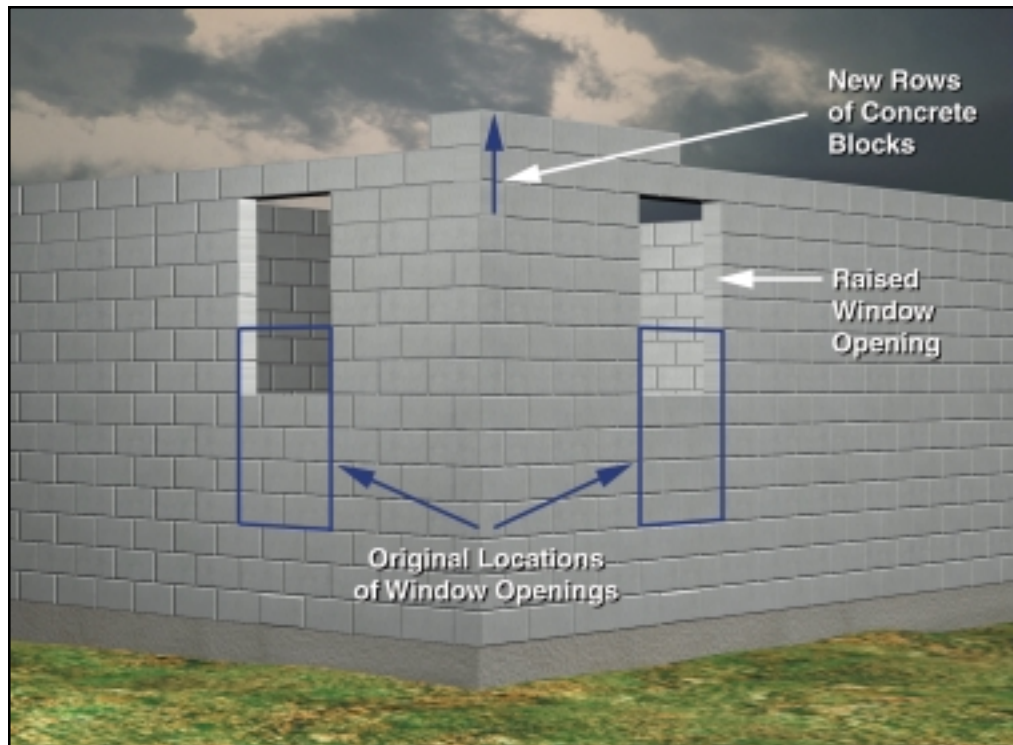
**Figure 11**

The tops of the walls and bottoms of the window openings are raised with concrete blocks.

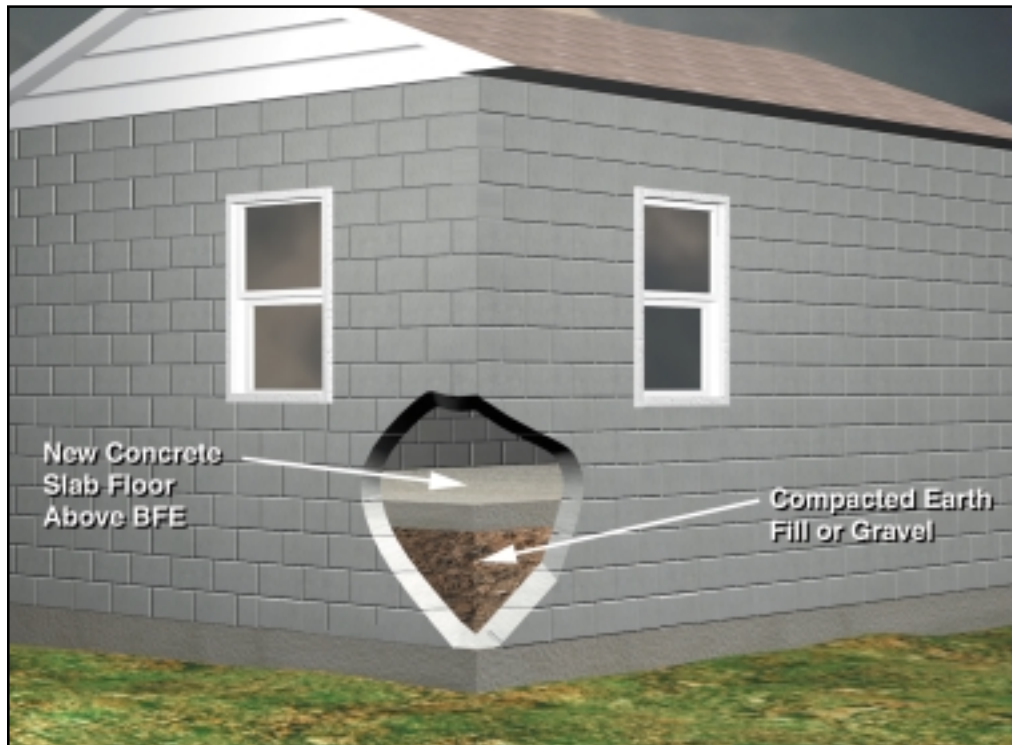
**Figure 14**

An alternative to building an elevated wood-frame floor is installing a new, elevated concrete slab floor on fill placed over the old slab.

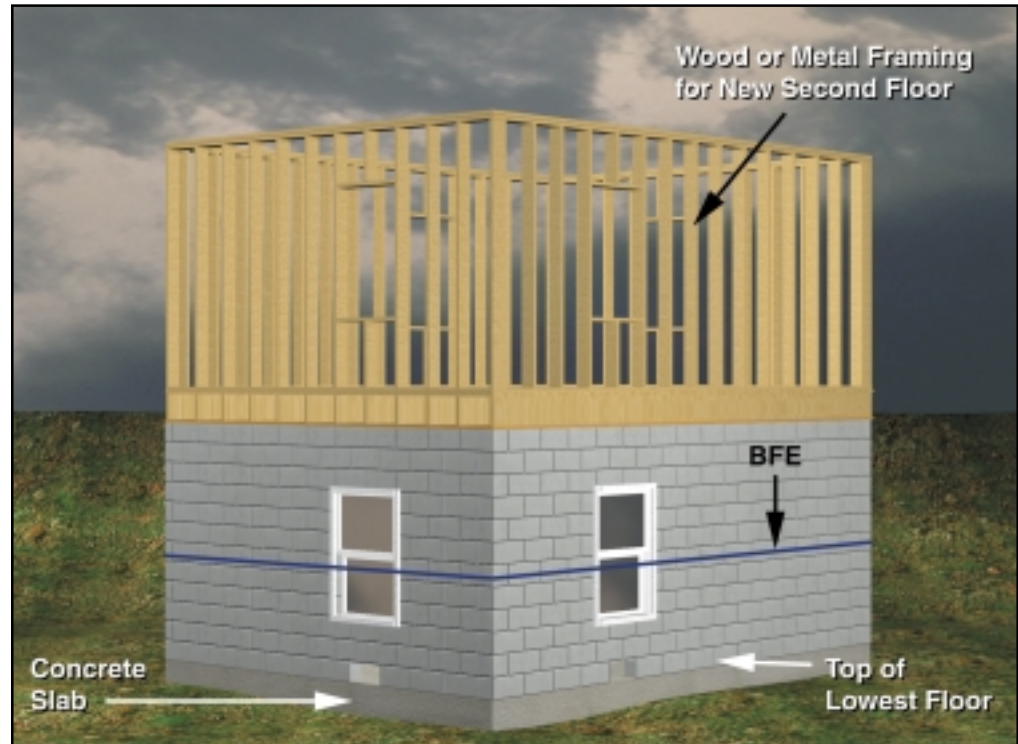
**Figure 15**

The new second-story floor and walls are built on top of the existing lower story.

Some homeowners prefer that the second story be constructed of masonry, but wood- or metal-framing is more common, primarily because it is lighter and less expensive. The roof is replaced, and blocks are removed from the walls to allow flood waters to enter and exit. Exterior sheathing is then added to the framed walls of the second story, the new windows are installed, and siding or stucco is applied to the sheathing (Figure 16).

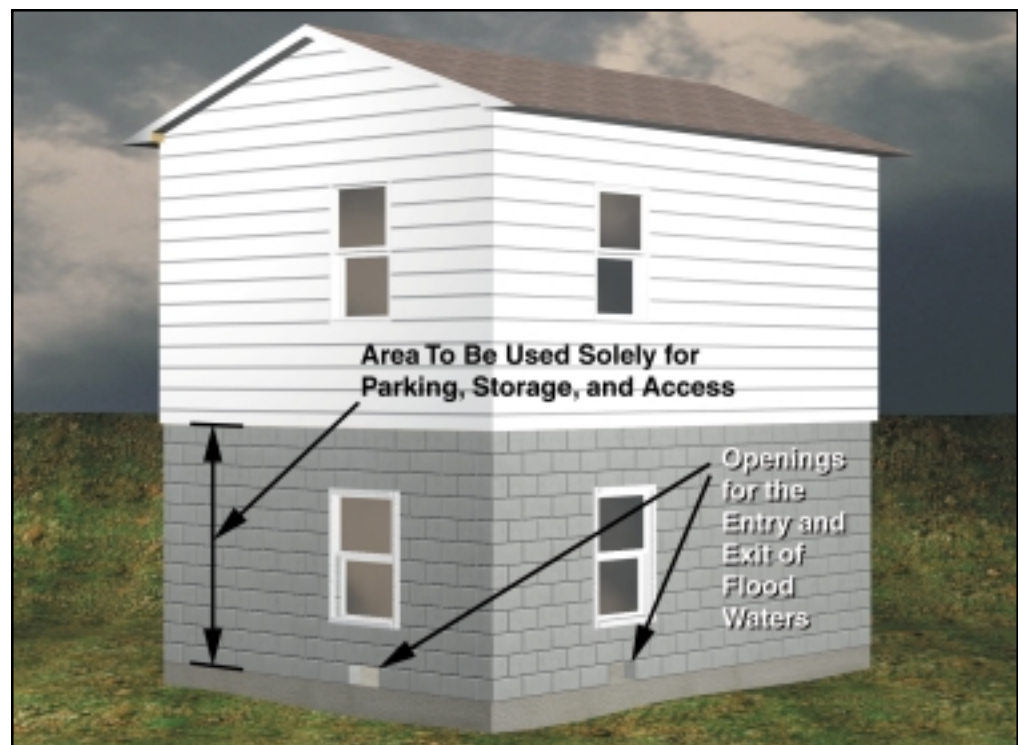
**Figure 16**

The new second-story walls are covered with siding or stucco.

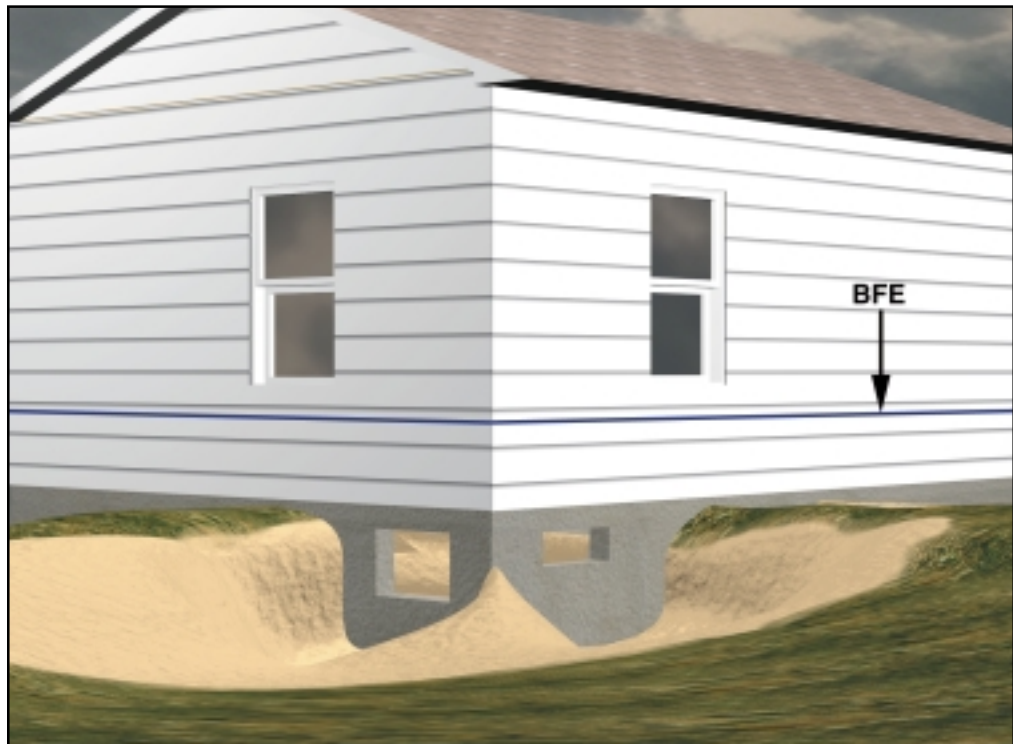
**Figure 17**

Trenches and tunnels under the slab provide access for the jacks and I-beams that will lift the house.

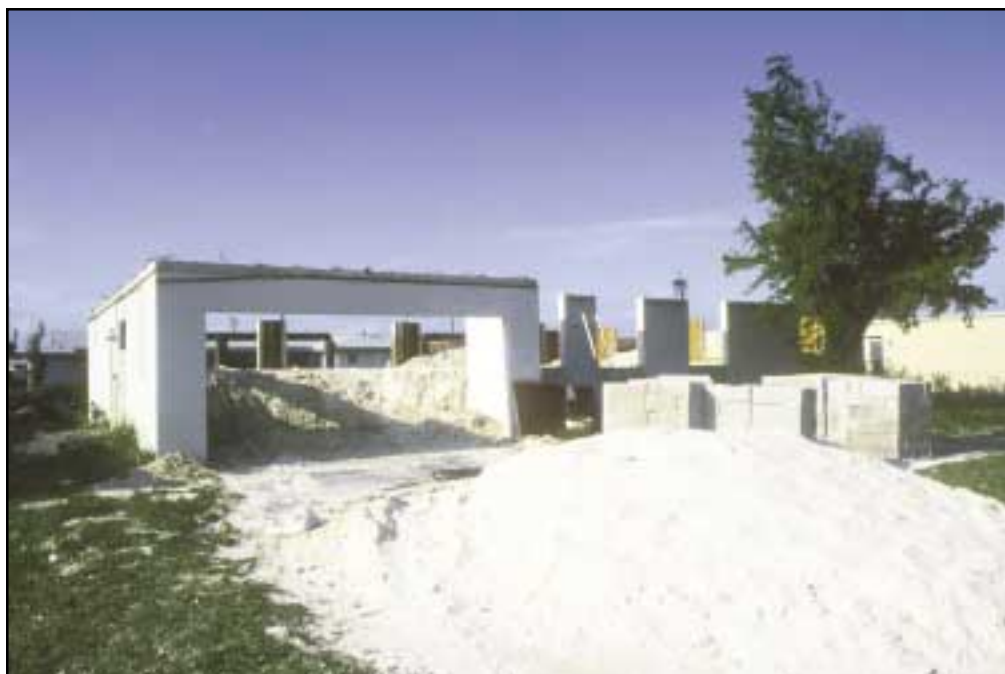
**Figure 22**

The front of the house at the beginning of the project. The interior walls and contents, which were destroyed or severely damaged by flood waters, wind, and rain, have been removed. Sand has been placed on top of the old slab to provide the base for the elevated lowest floor. The concrete blocks that will be used to extend the walls can be seen stored in the foreground.

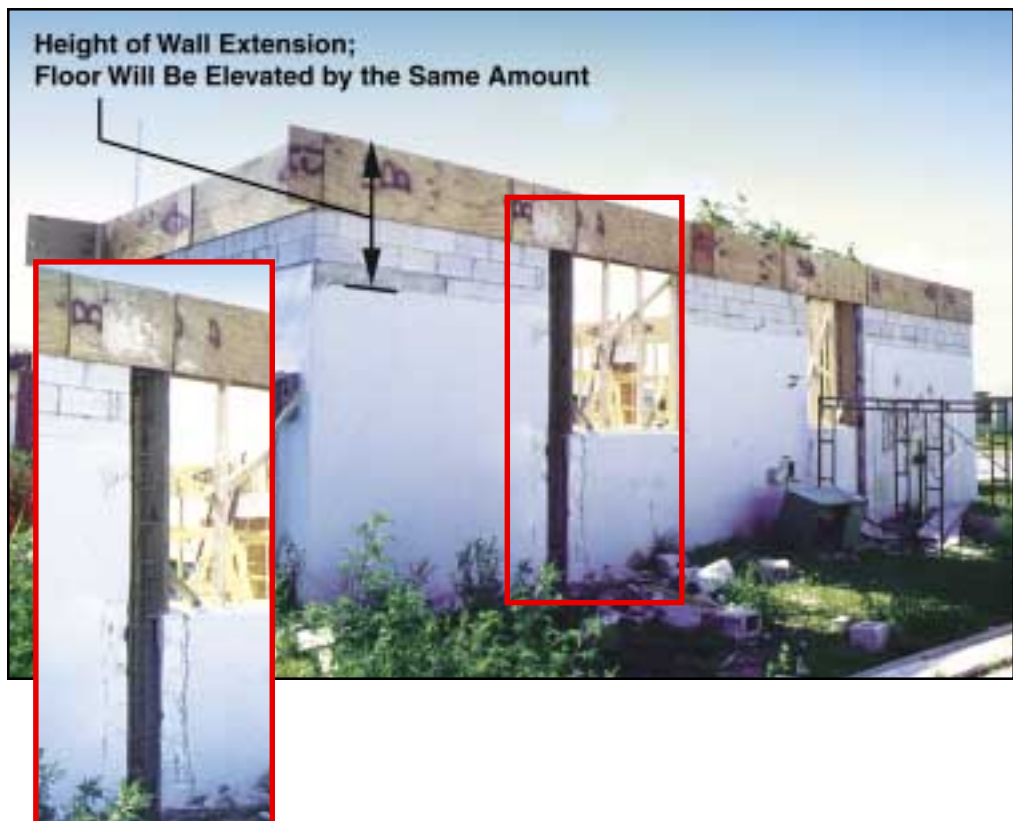
**Figure 24**

Another view of the extended walls. The vertical cuts in the walls next to the windows are for concrete tiedown columns that will be cast in place to further strengthen the extended walls against wind loads. The owner of this house was able to meet the elevation requirement by raising the floor only a few feet, as indicated by the amount that the walls have been extended.

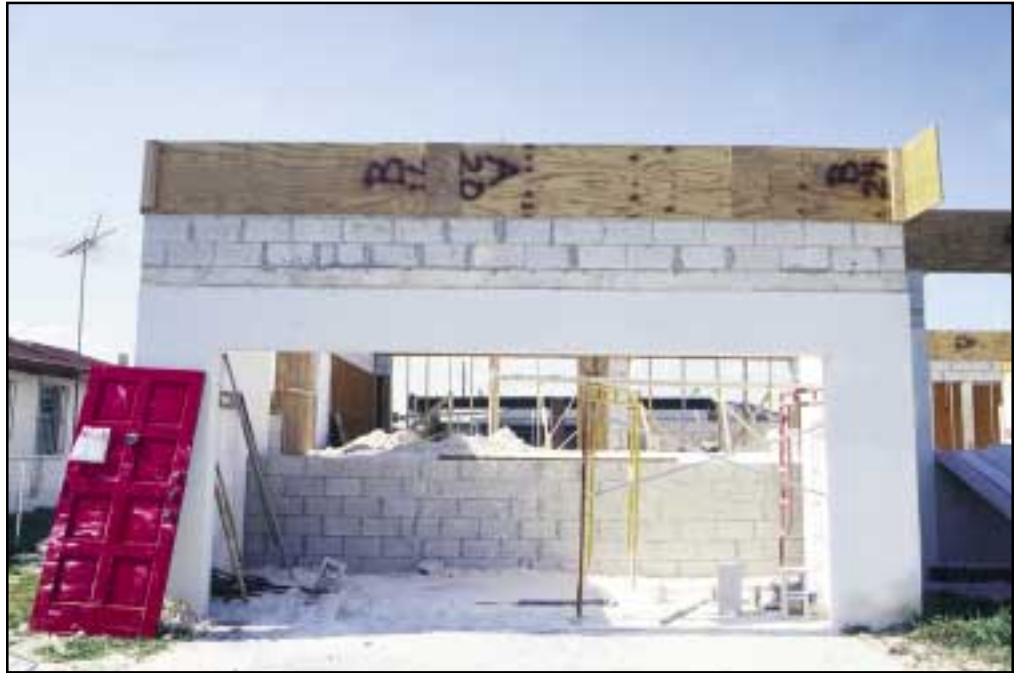
**Figure 25**

This view through the garage door reveals the different levels of the elevated slab floor, in the background, and the unelevated garage floor.

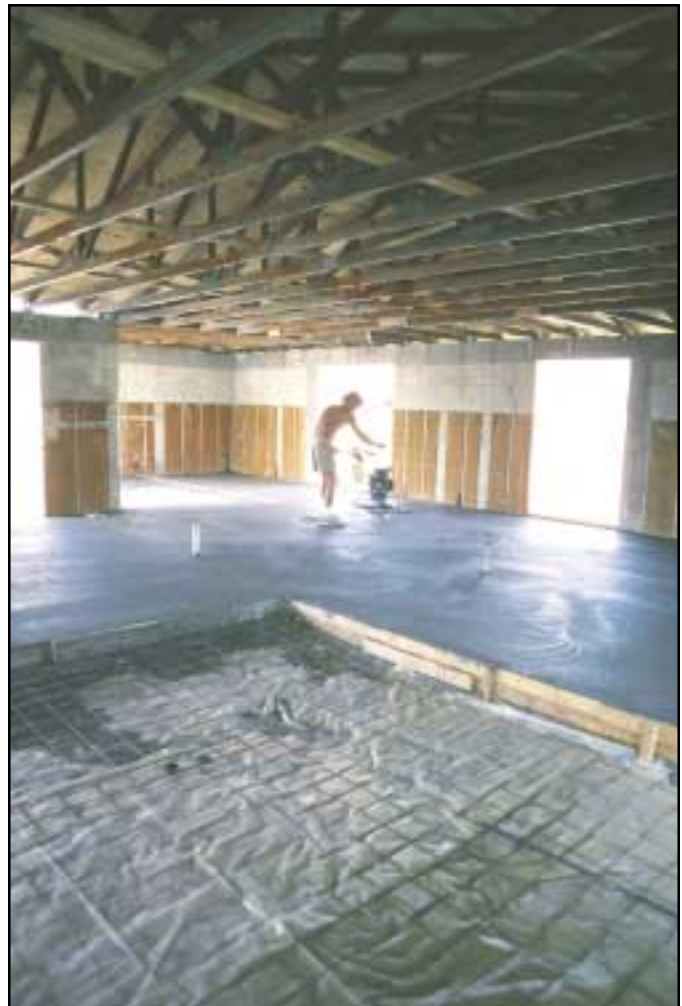
**Figure 26**

The roof has been rebuilt with the salvaged trusses, and most of the new concrete slab has been poured on top of the sand fill. The open area in the foreground, where plastic sheeting and wire reinforcement can be seen on top of the sand fill, is where the remaining part of the slab will be poured.

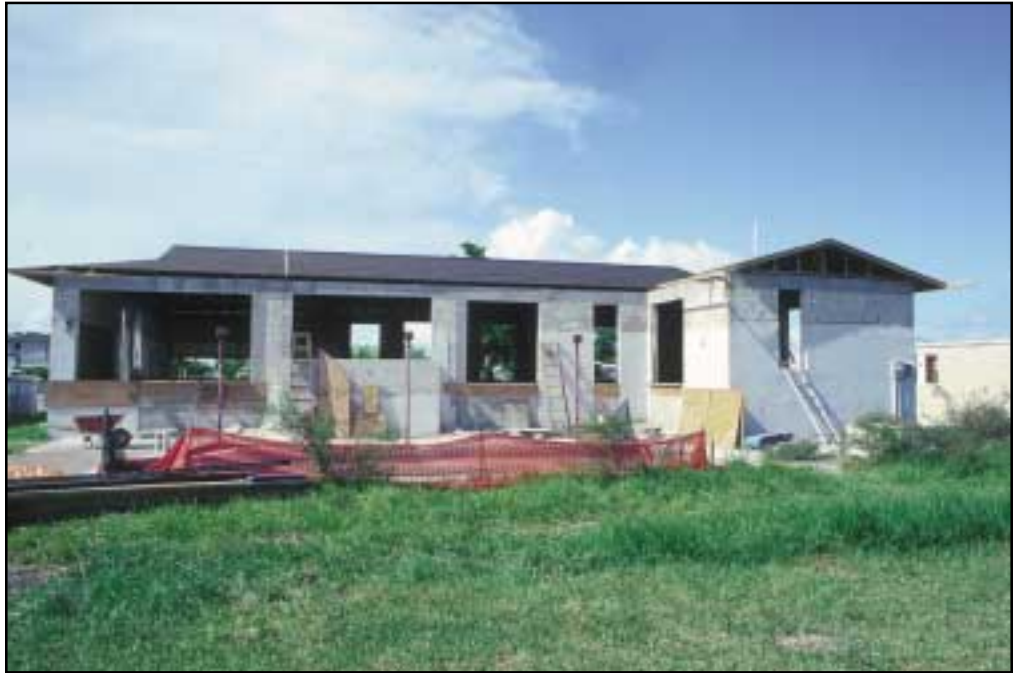
**Figure 27**

As work progresses, the elevated house begins to take shape.

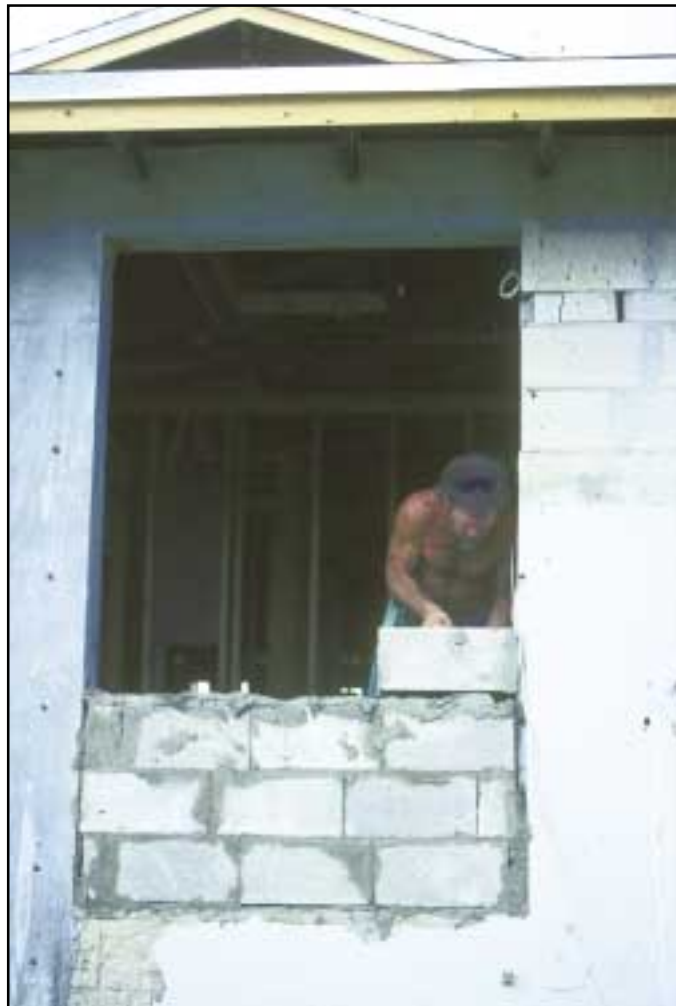
**Figure 28**

The bottoms of the original window openings are raised with concrete blocks.

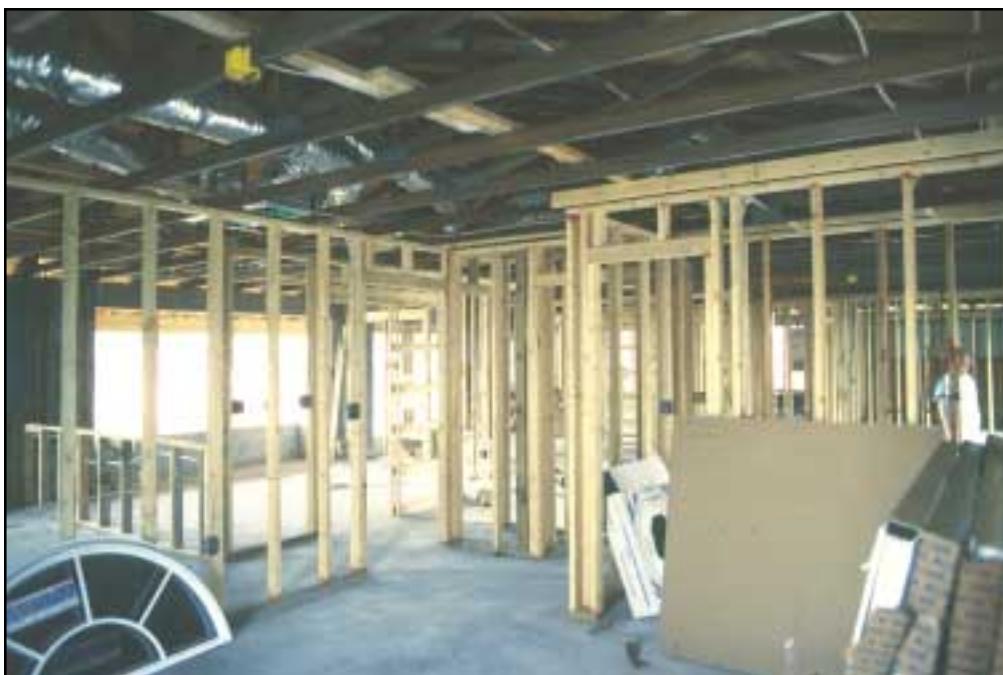
**Figure 29**

Windows and doors are added. The height of the raised front door shows the amount of elevation.

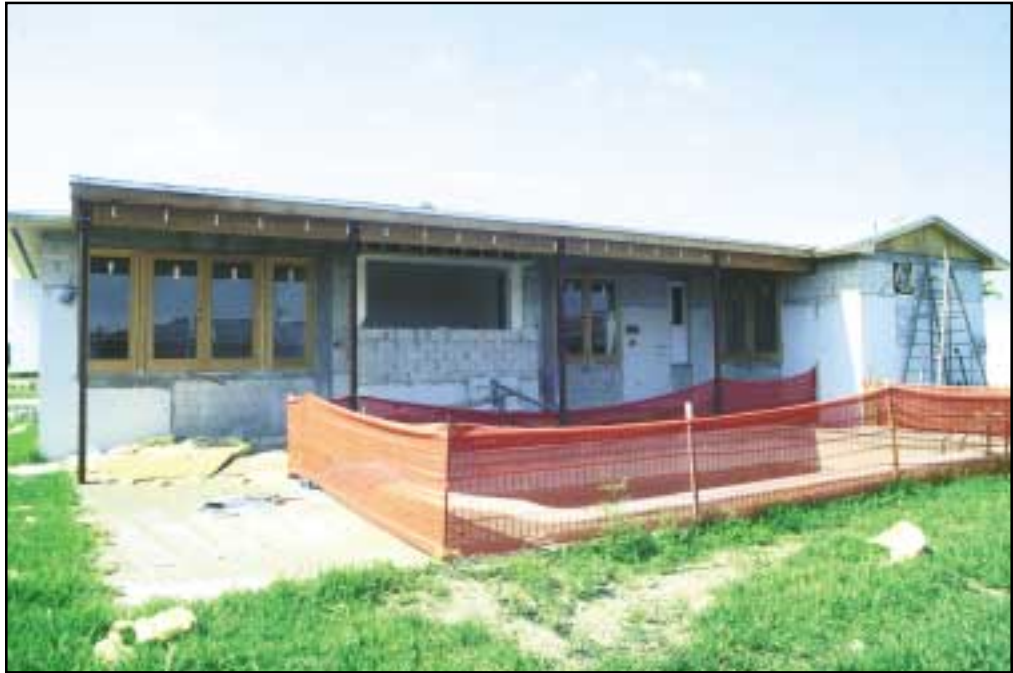
**Figure 31**

This view from the rear of the house shows that the project is almost complete.

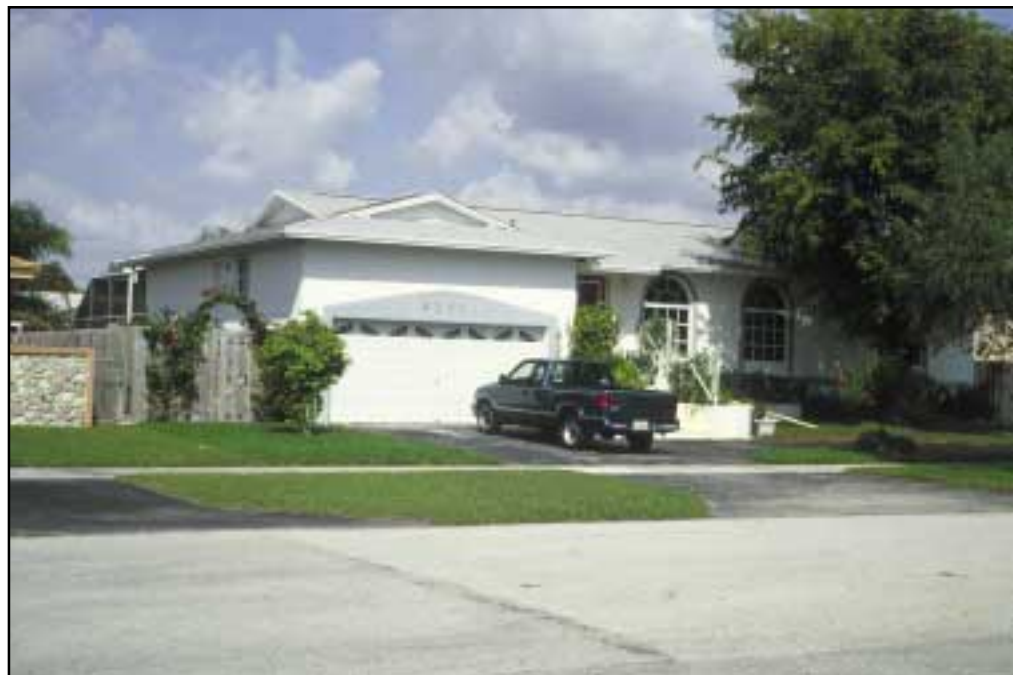
**Figure 32**

The final product: an attractive elevated house that meets local floodplain management requirements and is now much less vulnerable to flood damage. In addition, the house is now eligible for a lower rate of flood insurance coverage under the NFIP.

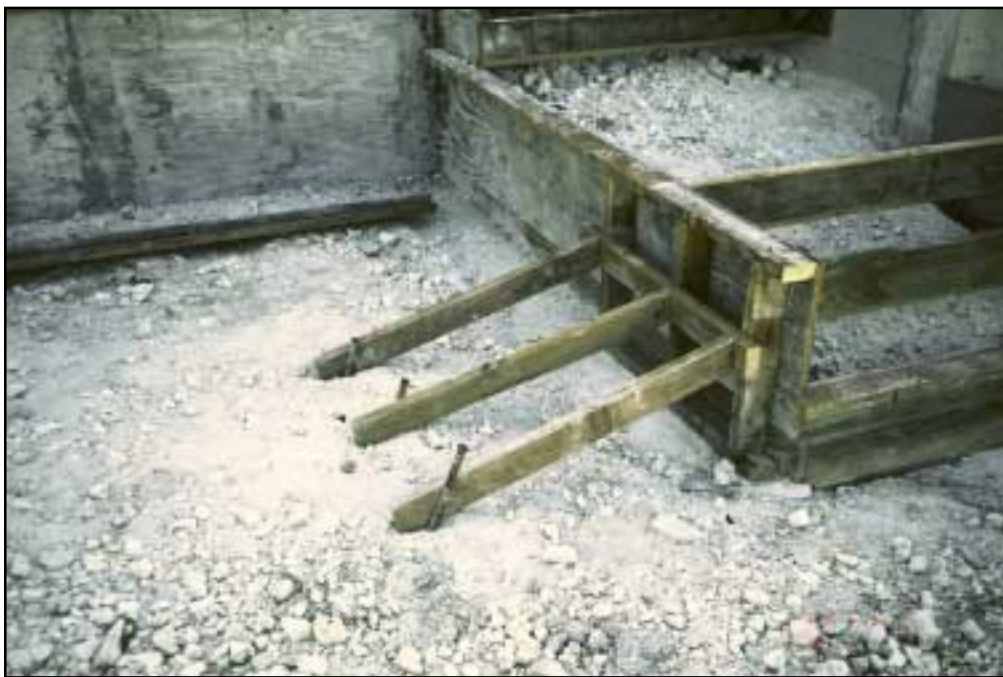
**Figure 33**

Wood framing for a new concrete staircase that will provide access to the elevated floor.

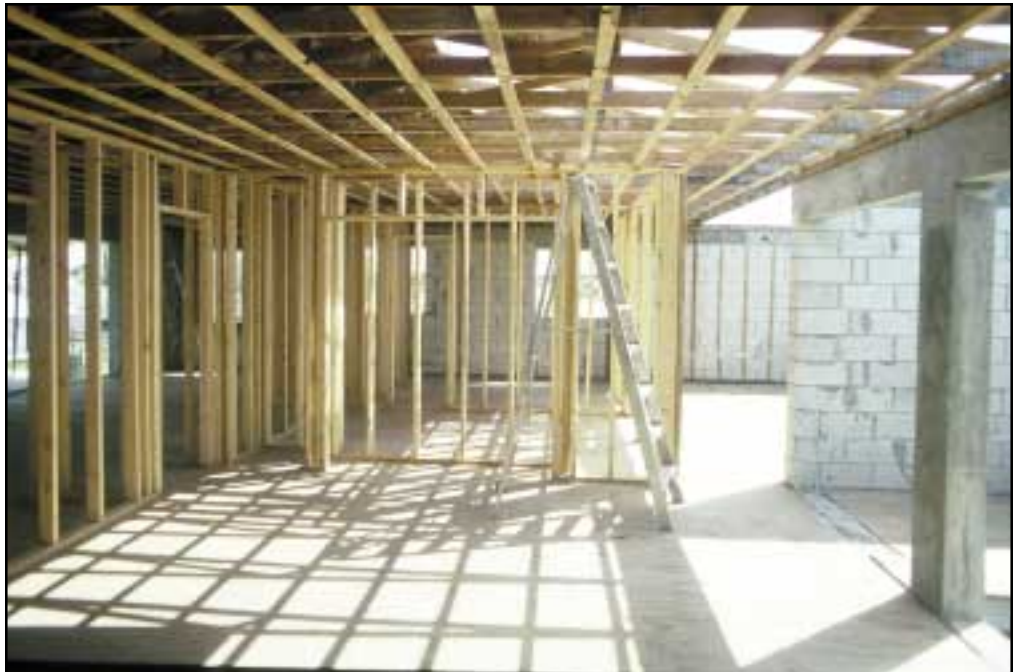
**Figure 34**

After the new concrete slab is poured, wood framing for interior walls is added.

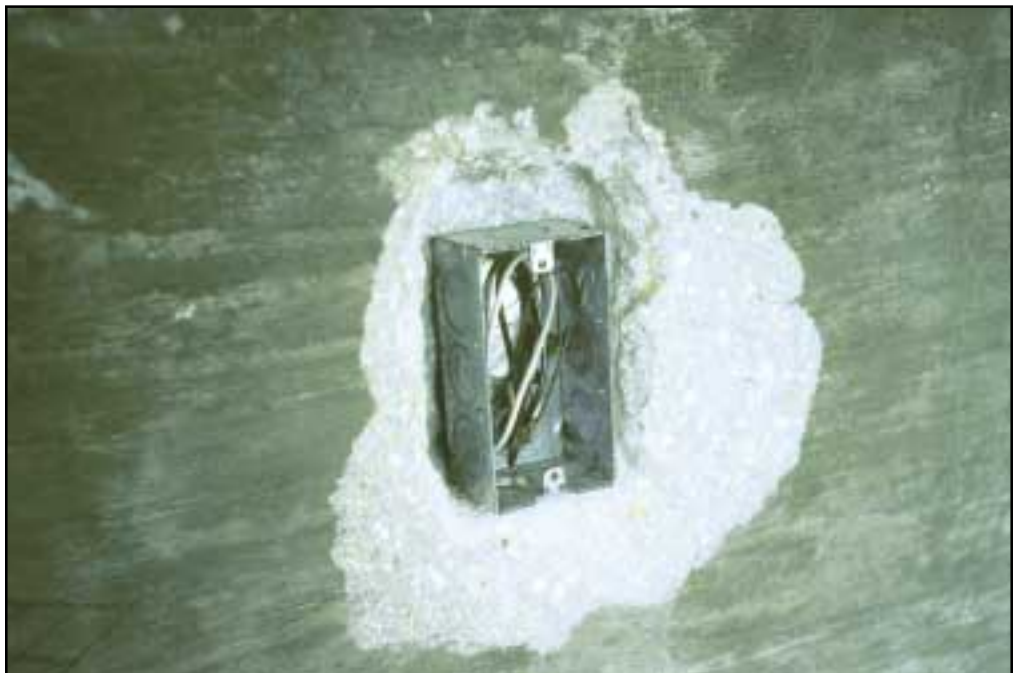
**Figure 35**

The electrical system is upgraded to meet current code requirements.

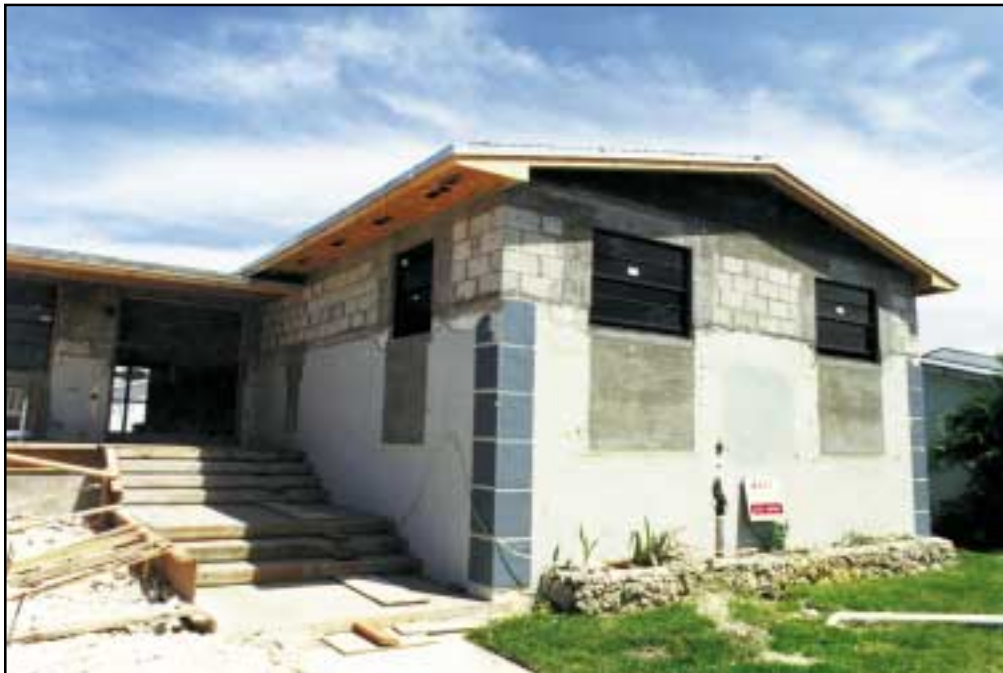
**Figure 36**

In this view from the front of the house, the amount of elevation is shown by the rows of concrete block on the tops of the original walls and by the raised window openings.

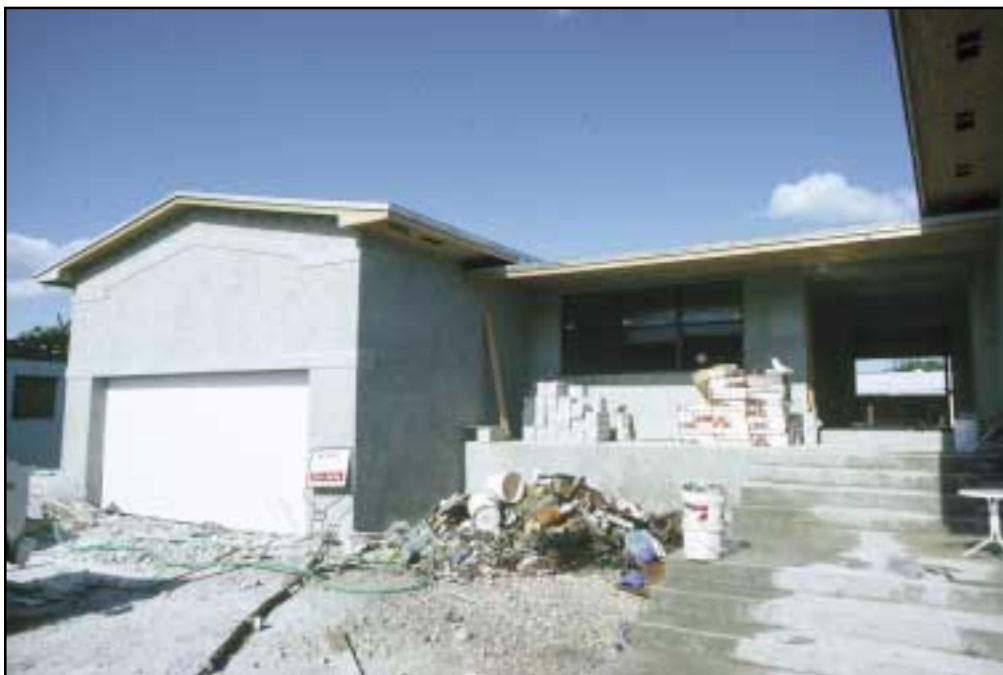
**Figure 37**

The project nears completion. In this house, as in Case Study 1, the level of the garage floor remains unchanged.

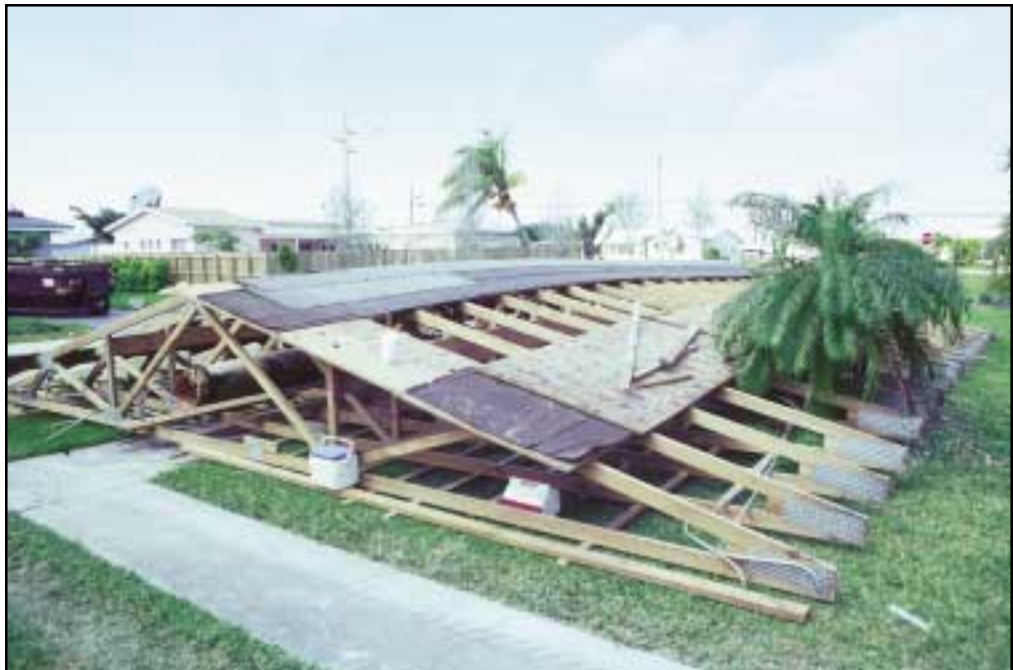
**Figure 39**

The roof of this house was removed as a single piece; the trusses were held together with bracing and portions of the original roof sheathing. This approach made it easier to reinstall the roof at the end of the project.
