FEDERAL EMERGENCY MANAGEMENT AGENCY

# *Above the Flood:* **ELEVATING YOUR FLOODPRONE HOUSE**

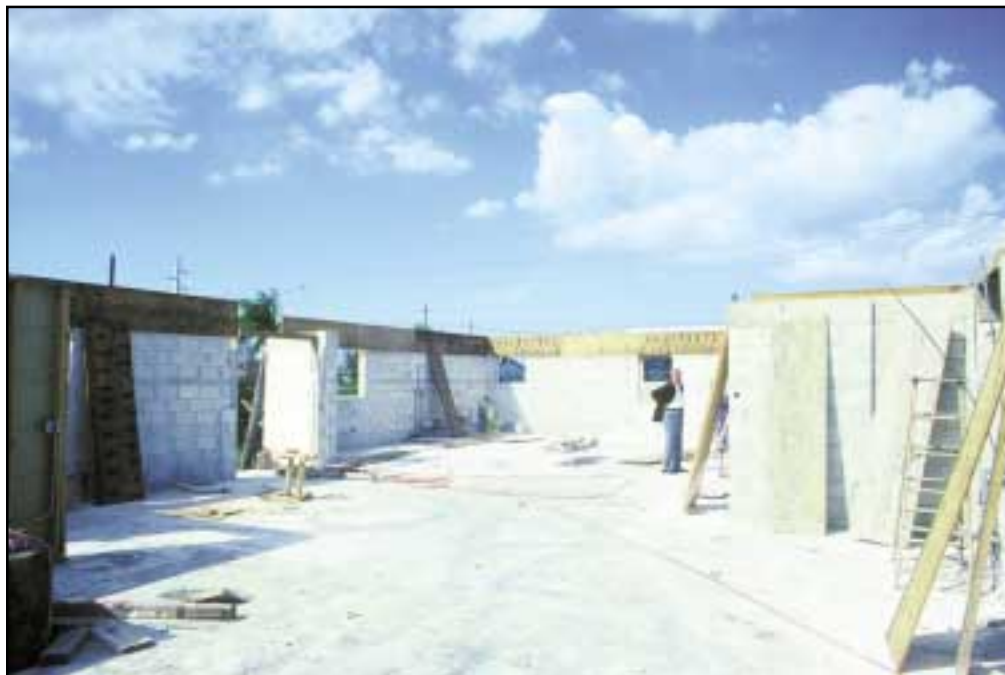
**Figure 40**

After the roof was removed and the storm-damaged interior gutted, the walls of the house were extended upward and a new bond beam added at the top.

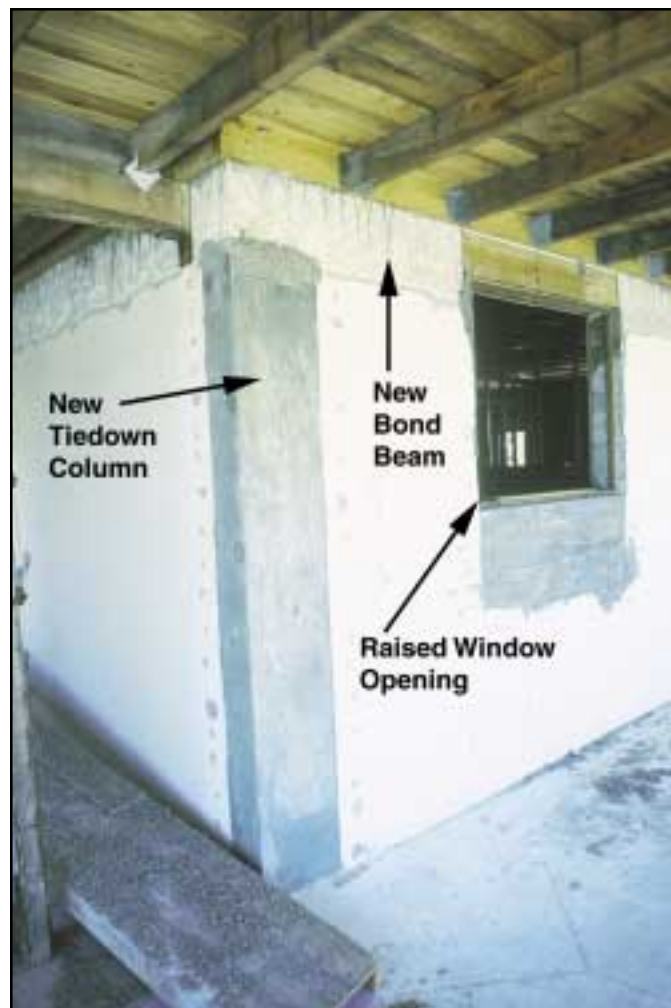
**Figure 41**

Note the new bond beam at the top of the extended wall, the new concrete tiedown column at the corner, and the raised window opening.

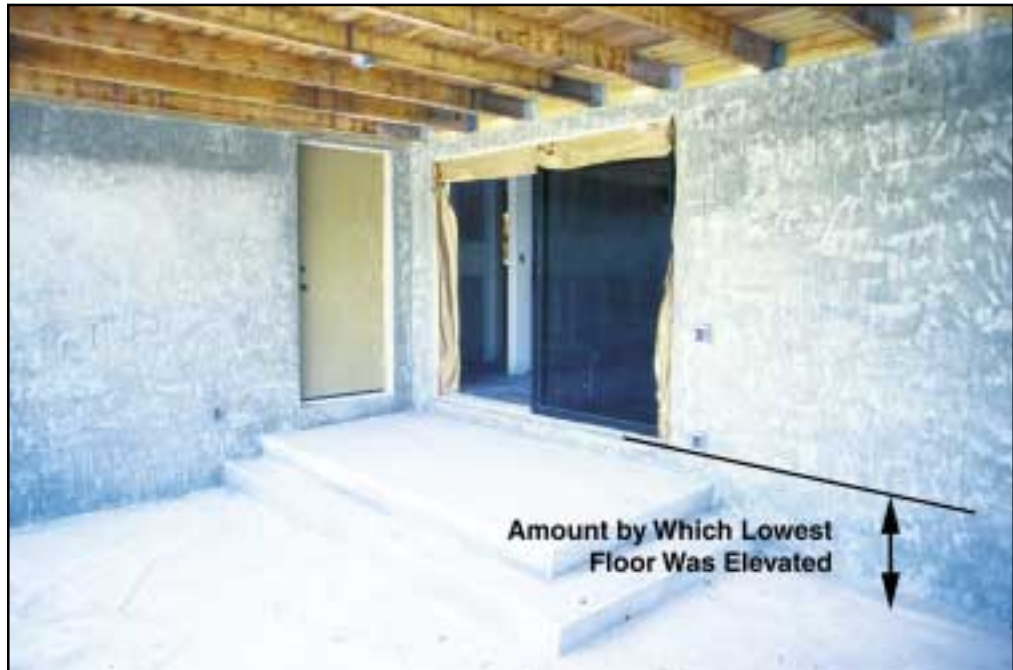
**Figure 42**

This view from the back of the house shows the height of the elevated slab floor.

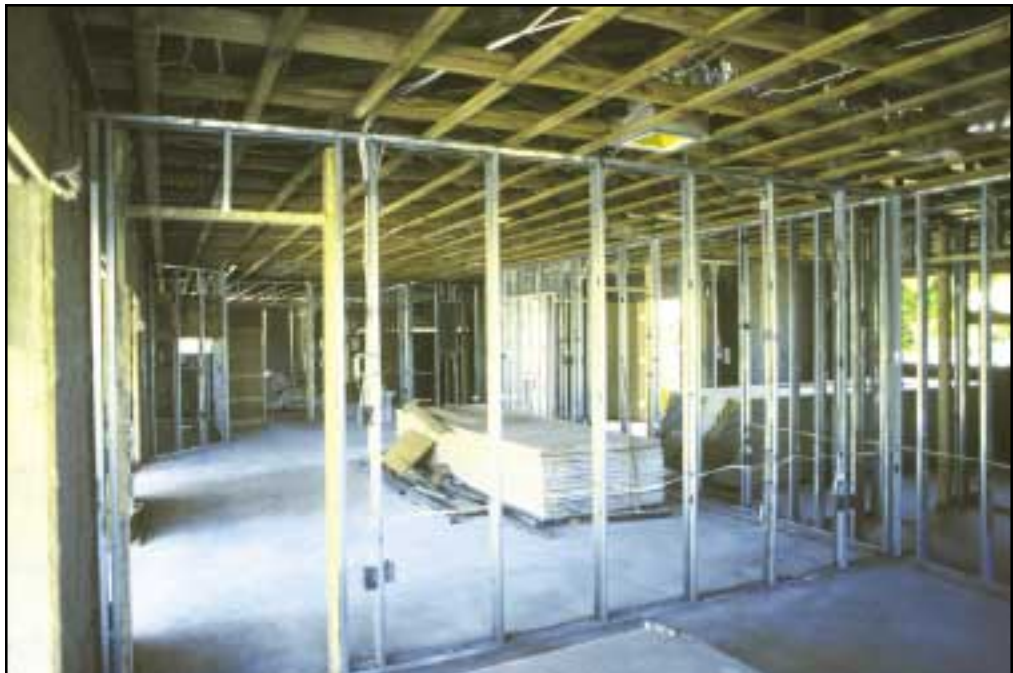
**Figure 43**

The owner of this house decided to use light-gauge metal framing for the new interior walls.

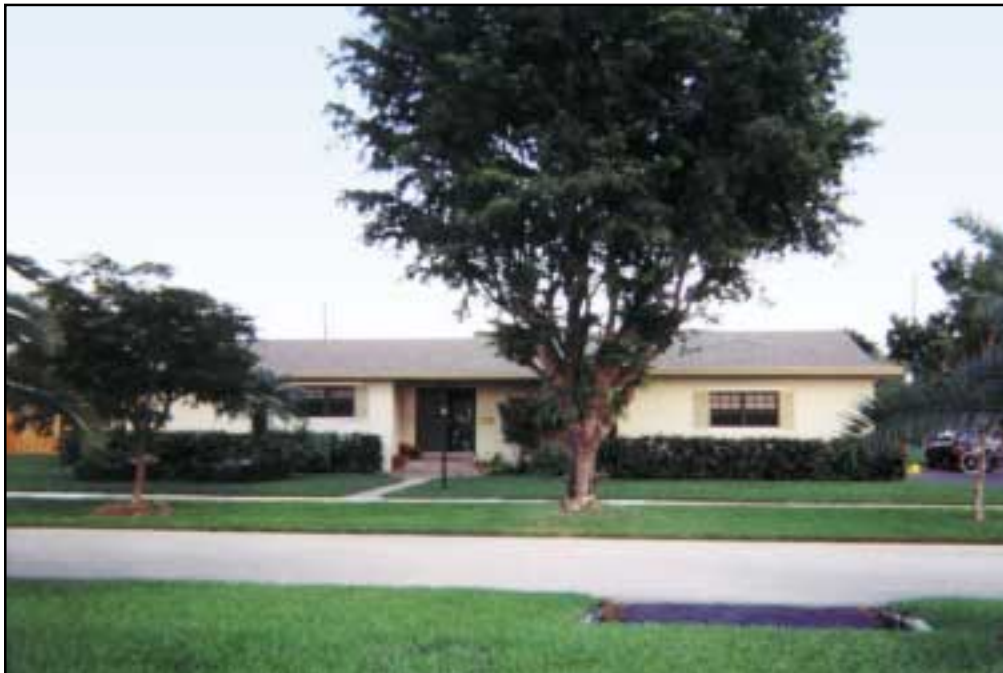
**Figure 44**

The final product. As in the first two houses, the garage floor remains at the original level. The relatively small amount of elevation required for this house has altered its appearance very little.

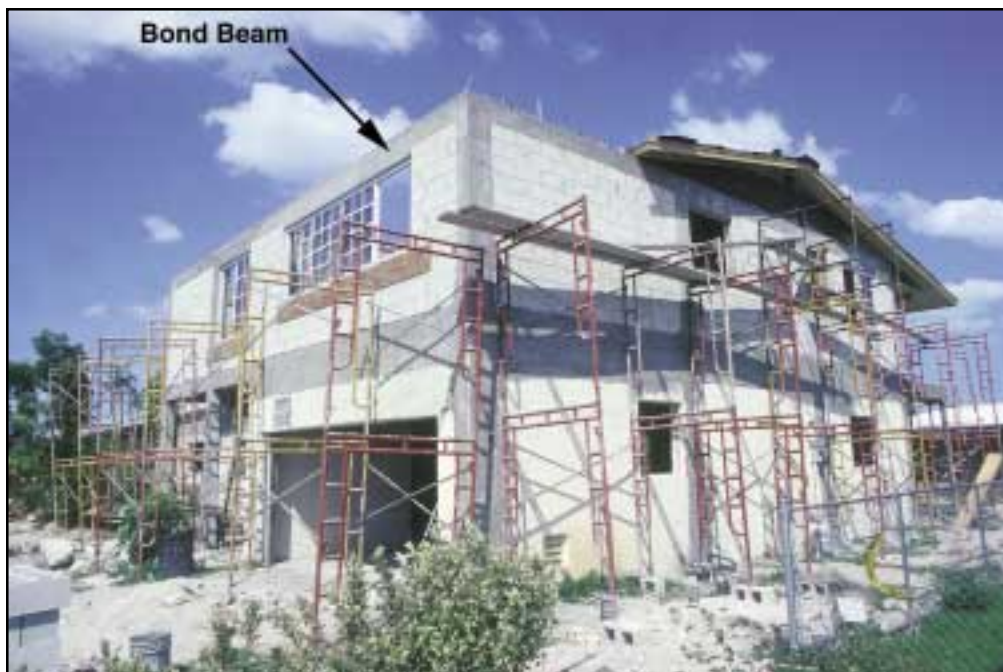
**Figure 45**

Concrete bond beams similar to those shown earlier were used in this house, but here they were installed on the tops of both the original first-story walls and the new reinforced concrete block second-story walls.

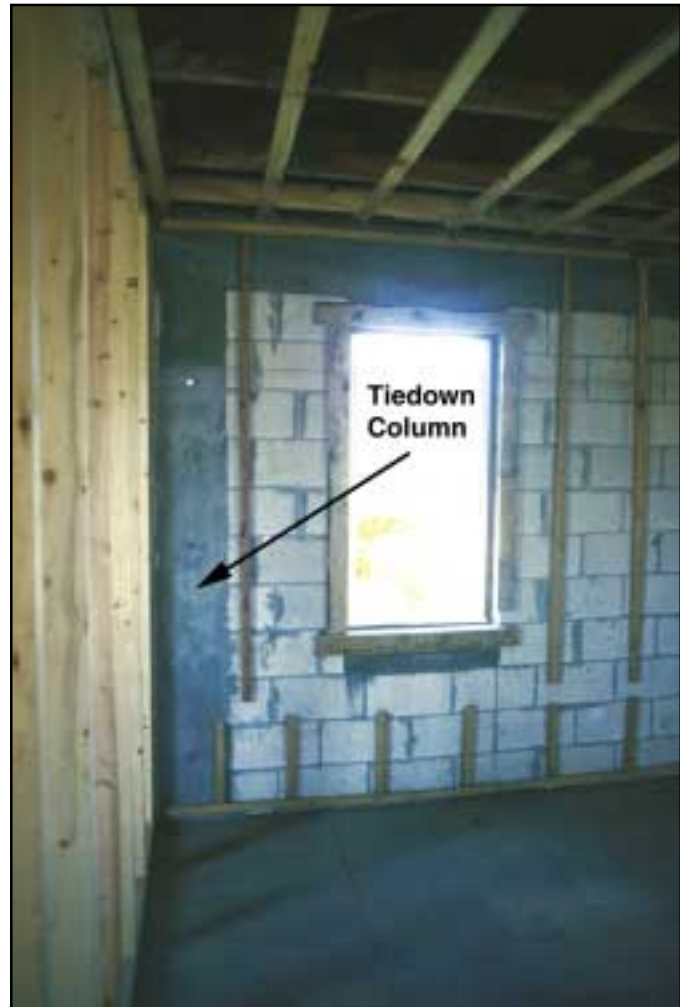
**Figure 46**

Concrete tiedown columns, such as the one to the left of the window in this photograph, were also used in this house.

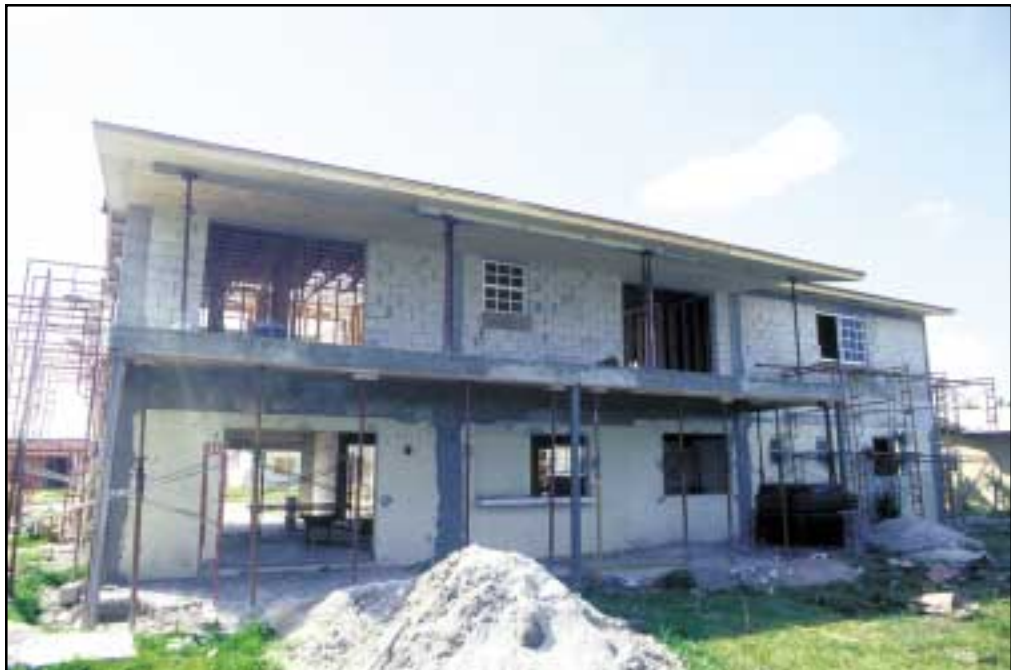
**Figure 47**

The tiedown columns extend down from the new second-story walls and into the original first-floor walls. The columns tie the first and second stories together and provide a continuous load path that helps the house resist the forces of high winds.

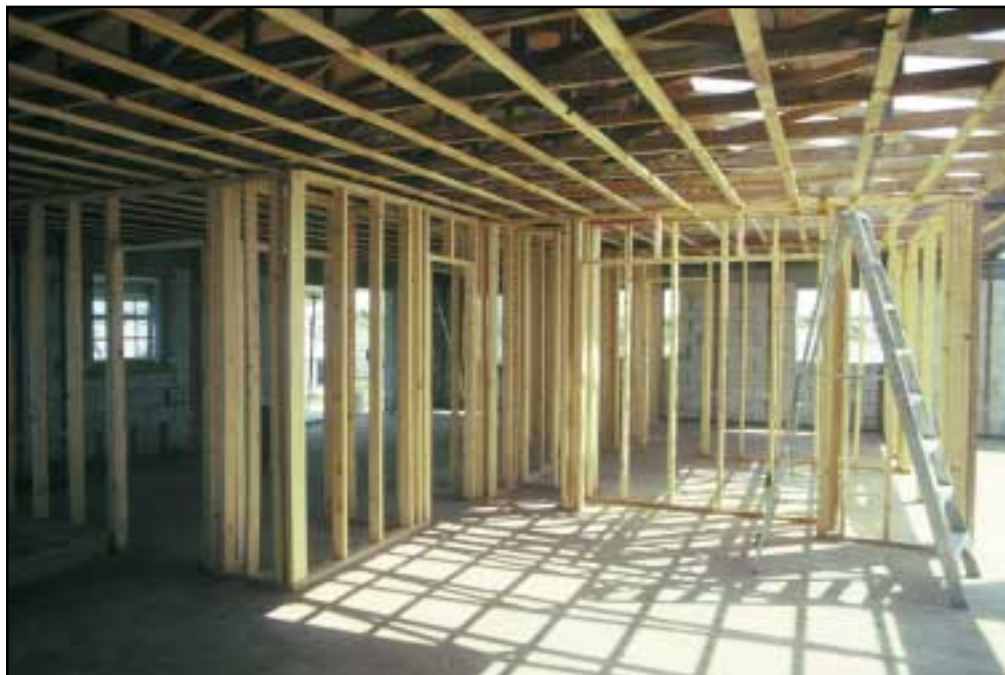
**Figure 48**

Wood 2 by 4 studs were used to frame the interior walls of the second story.

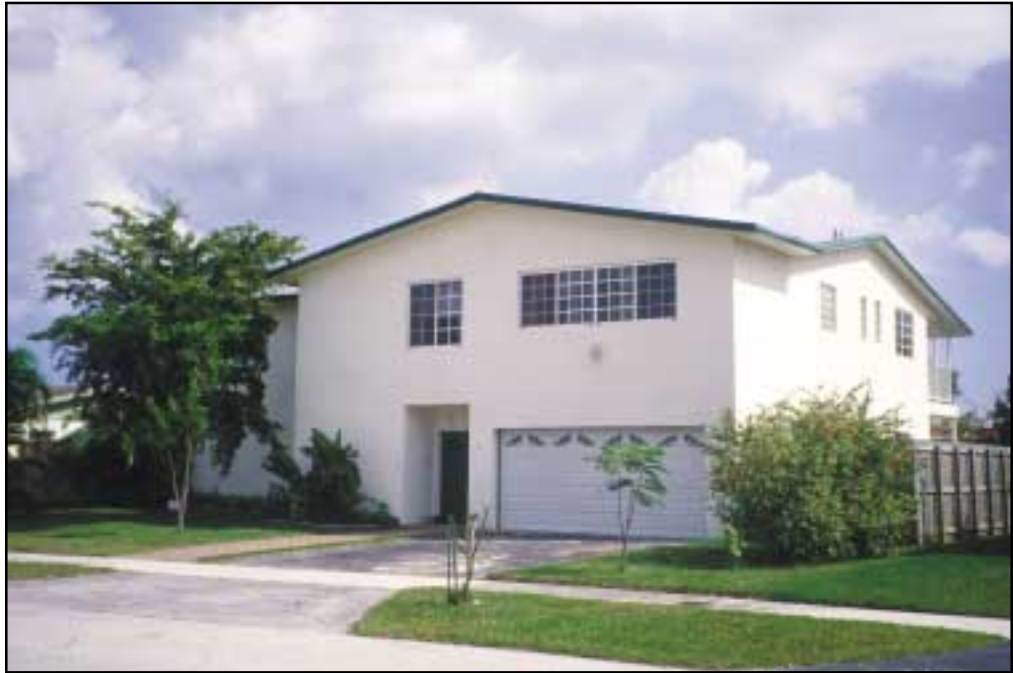
**Figure 50**

Not only does the completed house meet the requirements of local codes and the NFIP regulations, it now includes a substantial amount of parking and storage space below the new living level. In addition, because the lowest floor is now over 4 feet above the regulatory flood elevation, the house is eligible for NFIP flood insurance at a greatly reduced rate of coverage.

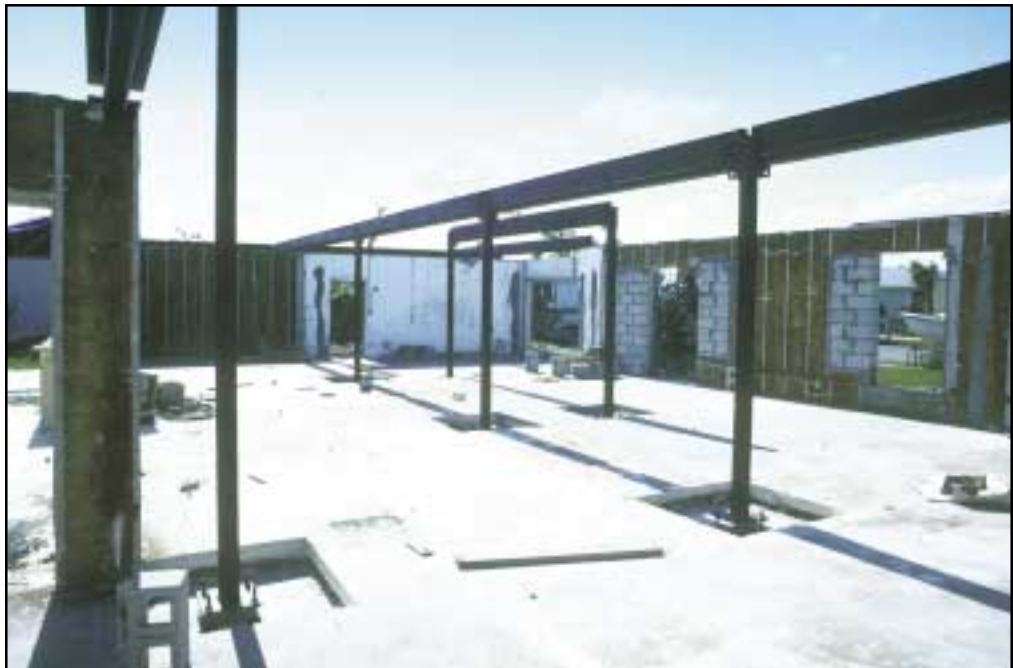
**Figure 51**

The storm-damaged first story has been gutted in preparation for construction.

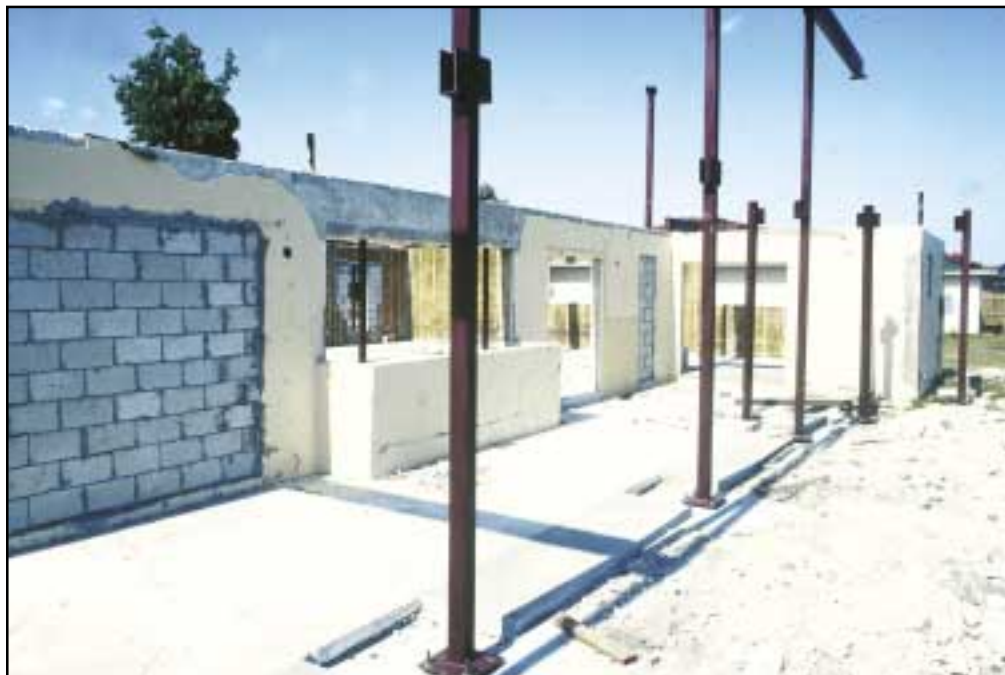
**Figure 52**

The existing first-story walls have been strengthened by the addition of concrete block. Metal columns and beams have been added to help support the new second story.

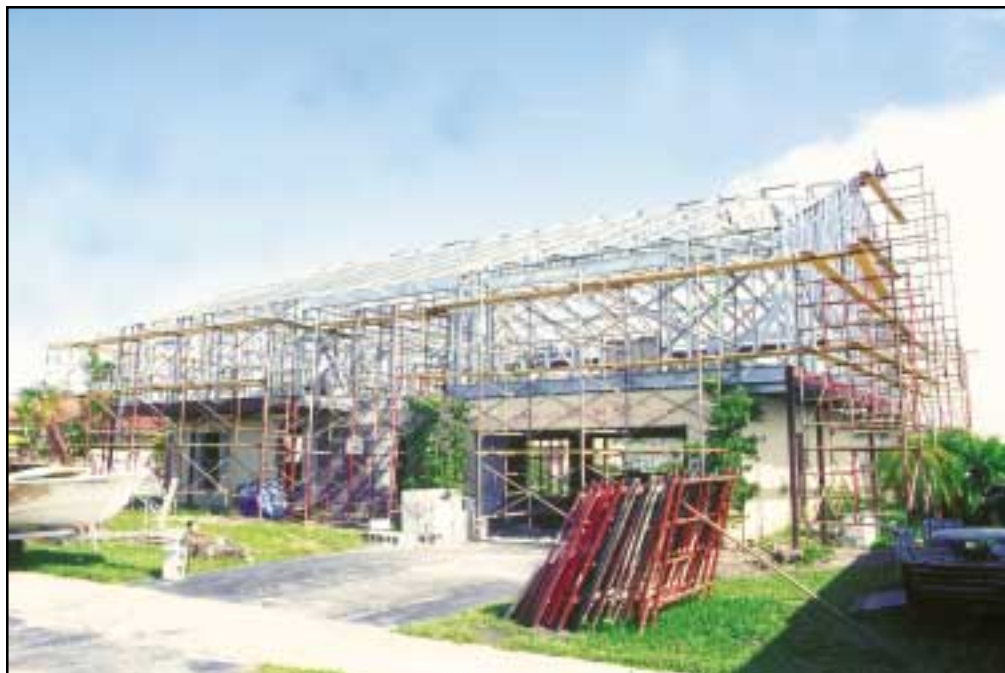
**Figure 53**

As the second story takes shape, its size in relation to the size of the original house becomes apparent.

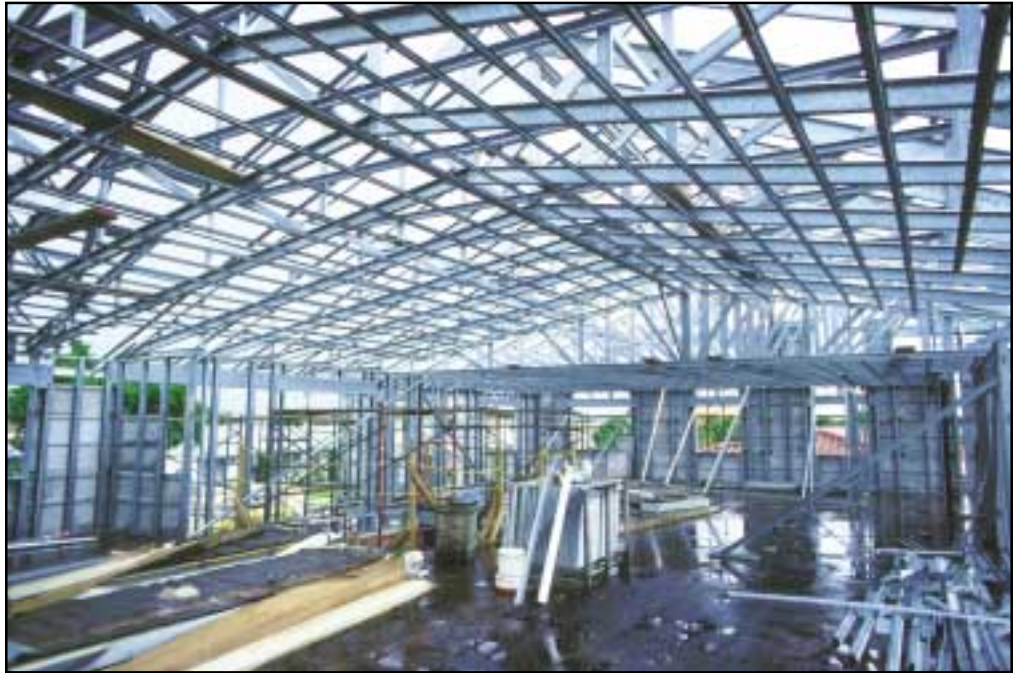
**Figure 54**

Metal framing is used for the new second story, including the walls and roof support system.

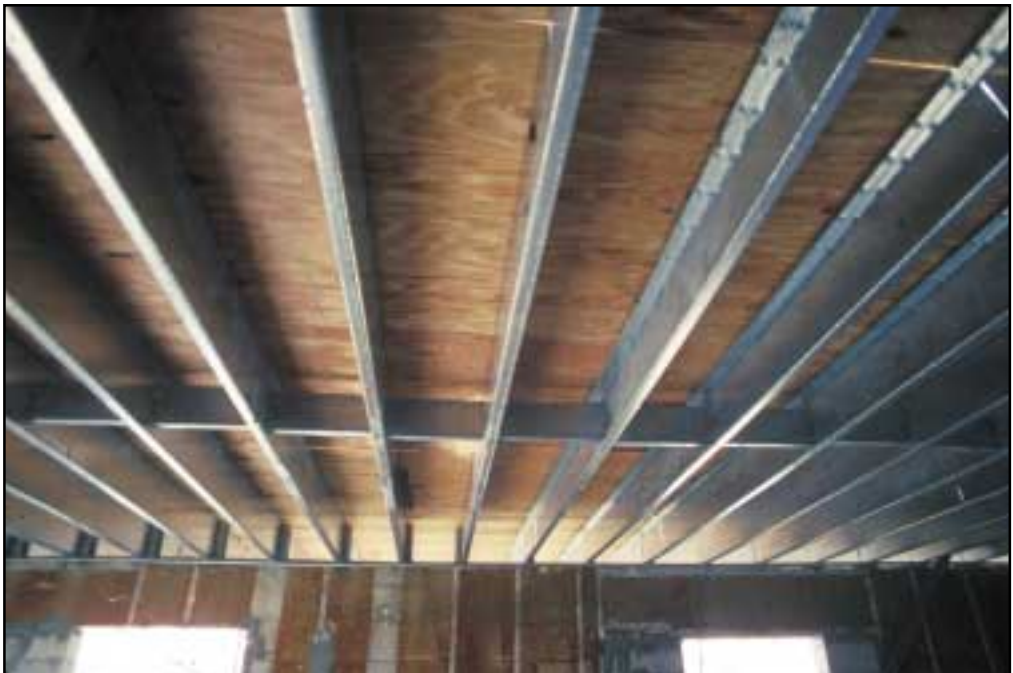
**Figure 55**

Metal framing also supports the floor of the new second story.

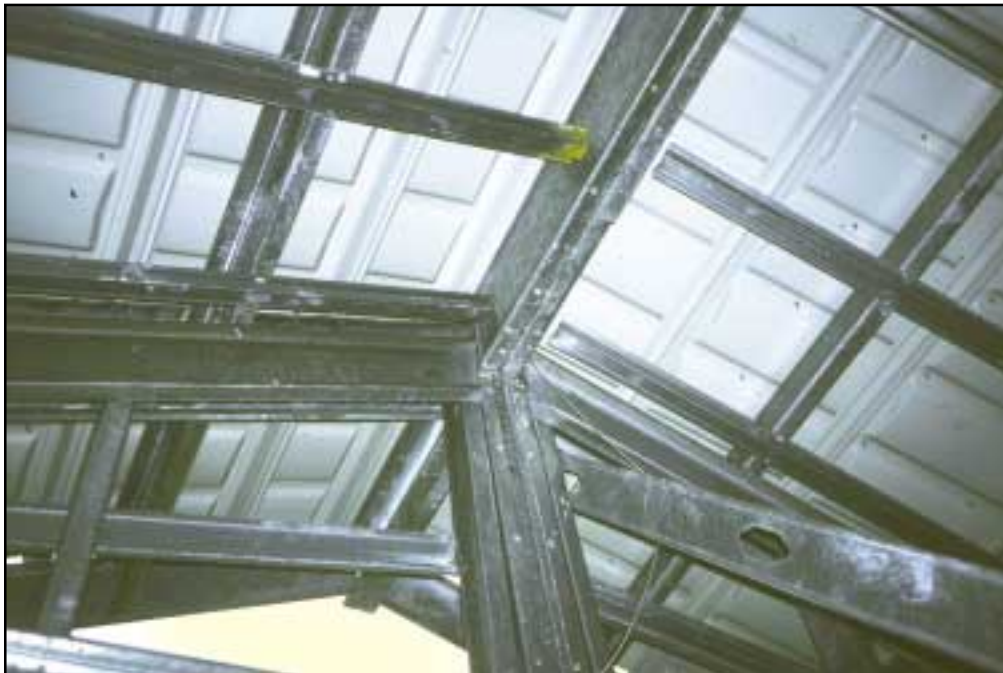
**Figure 56**

One advantage of metal framing is its relatively light weight. An additional advantage is that the screws used to attach metal-frame components provide strong connections.

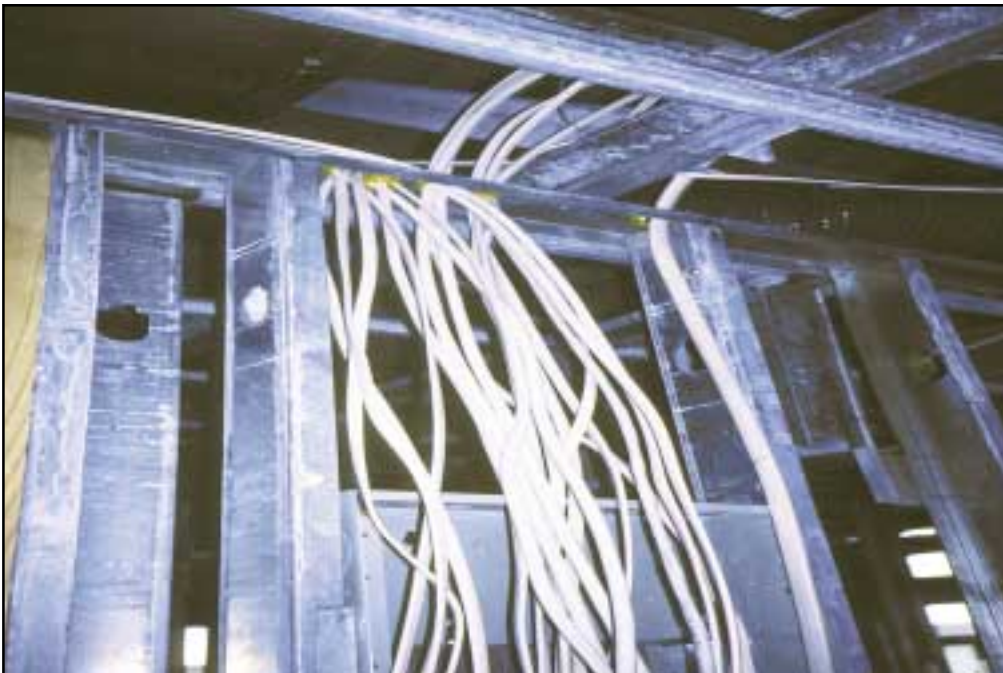
**Figure 57**

The project progresses with wiring and other utility work. As in each of the other house elevation projects, all current building code requirements must be met.

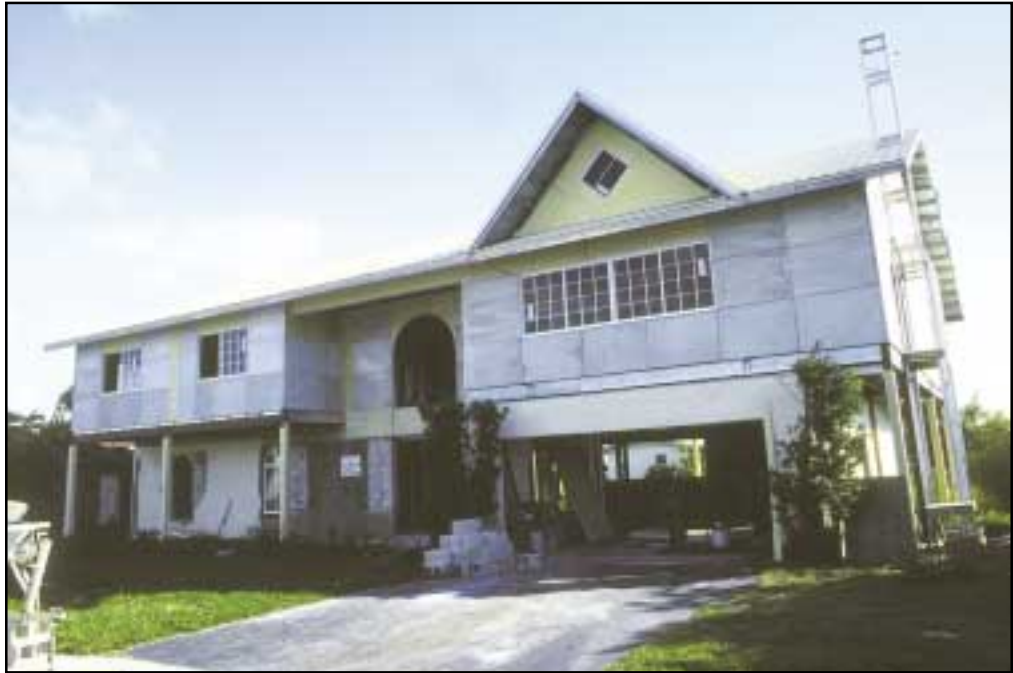
**Figure 58**

The new second story nears completion. The roof is made of formed metal panels.

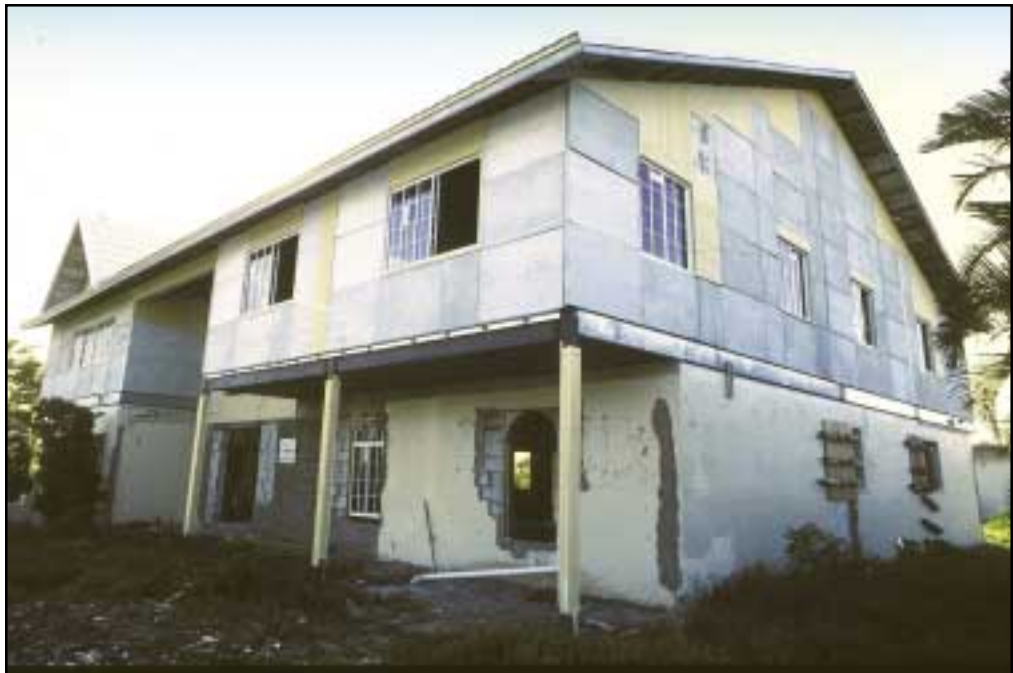
**Figure 59**

The exterior walls consist of prefabricated concrete panels. Innovative techniques such as those employed in this project are helping homeowners who need practical and economical methods of repairing and protecting their houses.

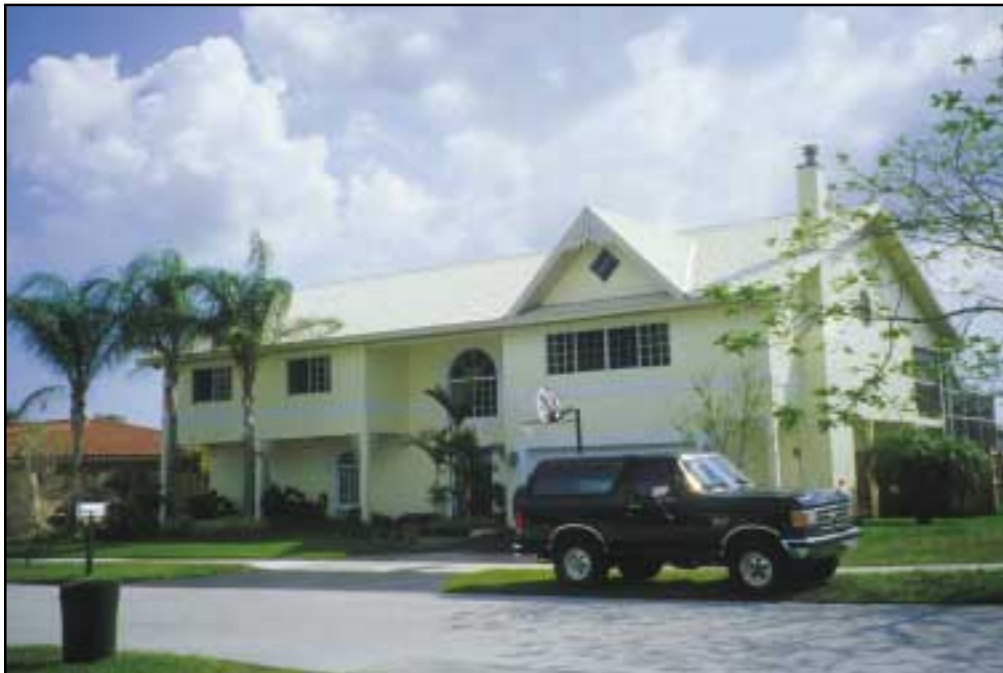
**Figure 60**

The completed house has the appearance of a typical two-story residence. As in the house in Case Study 2, the lower floor is used only for parking, storage, and building access; the new second story provides the living space.

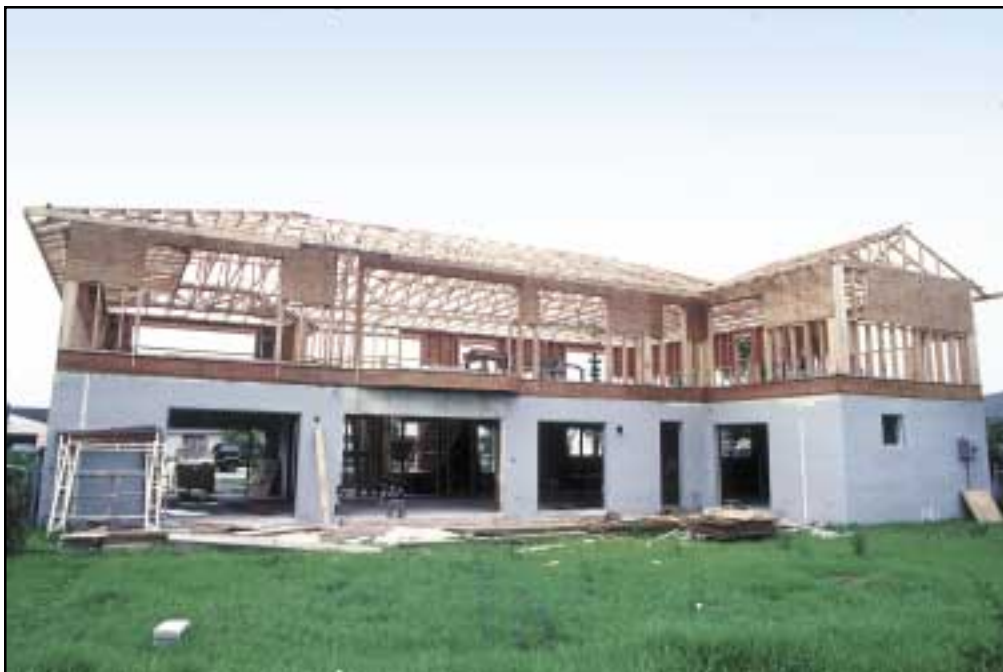
**Figure 61**

The wood-frame second story takes shape.

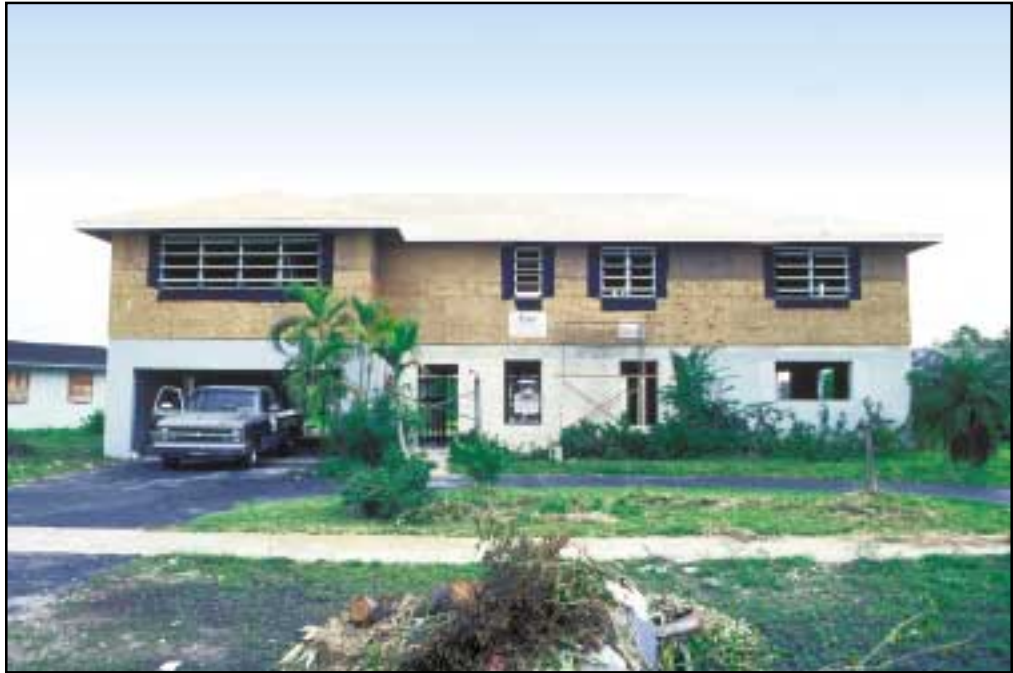
**Figure 62**

After the wood framing was completed, the roof and exterior wall sheathing were added.

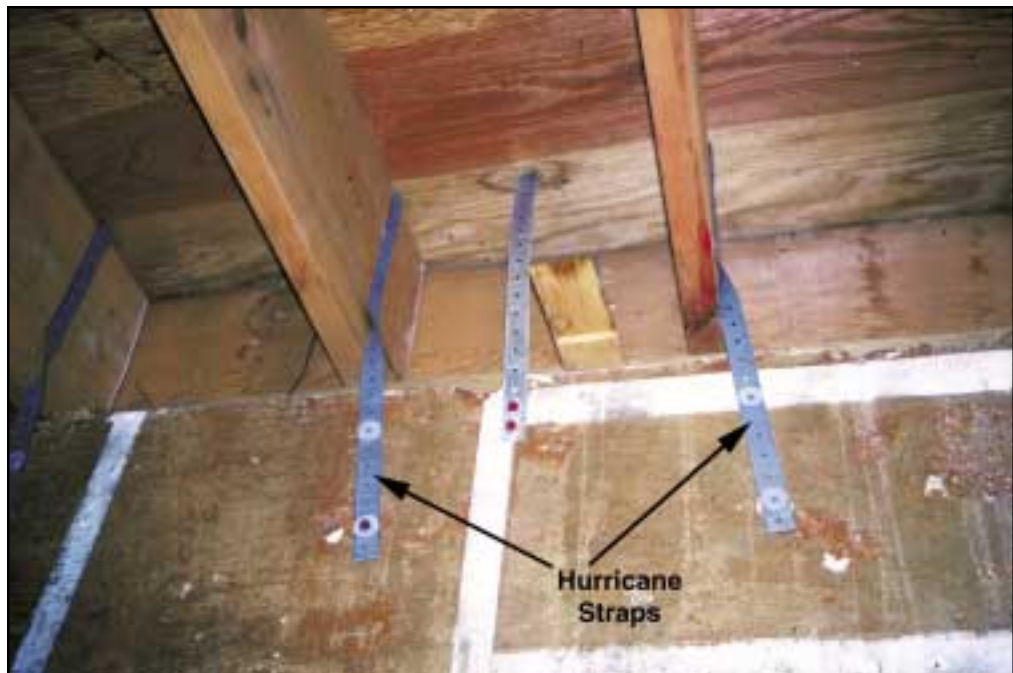
**Figure 63**

The new second-story walls are securely connected to the original first-floor walls with galvanized metal hurricane straps.

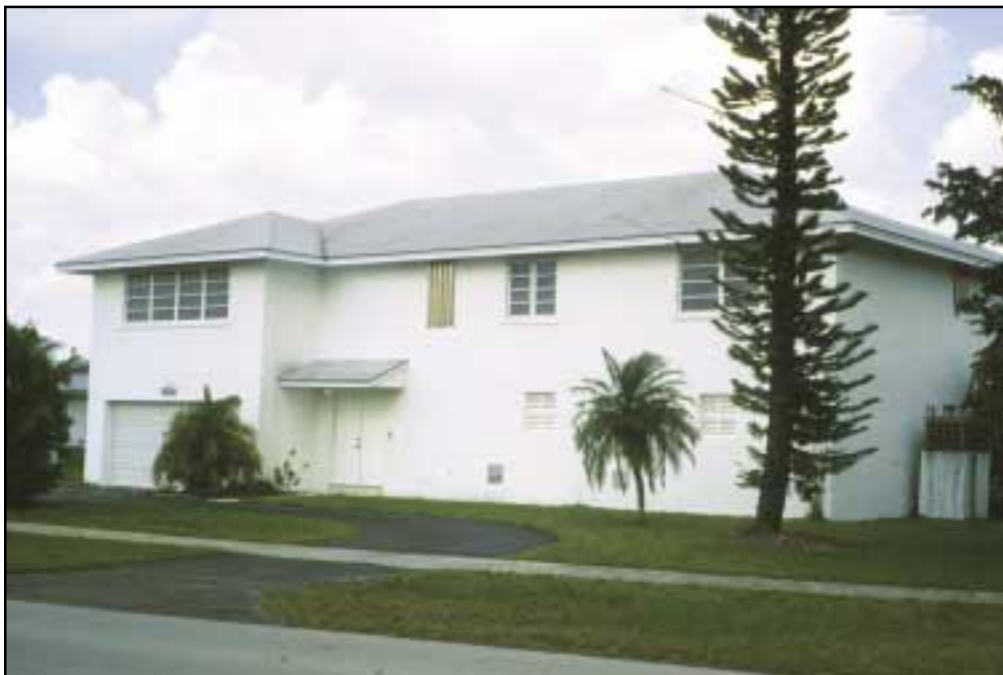
**Figure 64**

From the outside, the completed house, with its stucco walls, looks like a conventional masonry house.

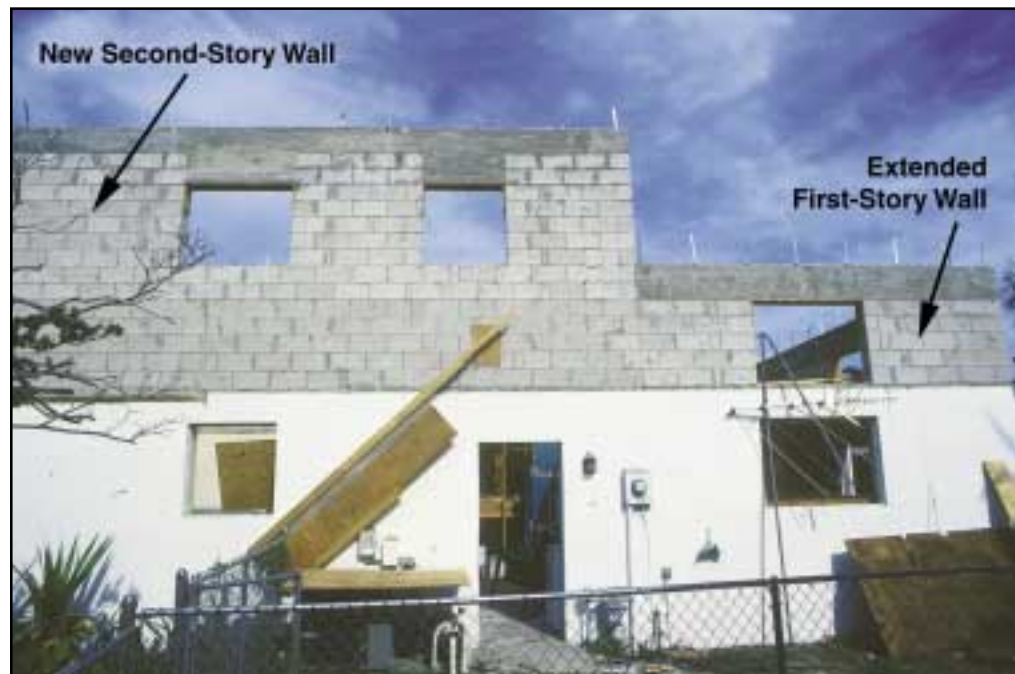
**Figure 65**

After the house was gutted, the walls were extended upward with reinforced concrete block. In this view from behind the house, the rear wall of the new second story can be seen on the left and the extended first-story wall on the right. Note the new raised window opening in the extended wall, just above the original opening.

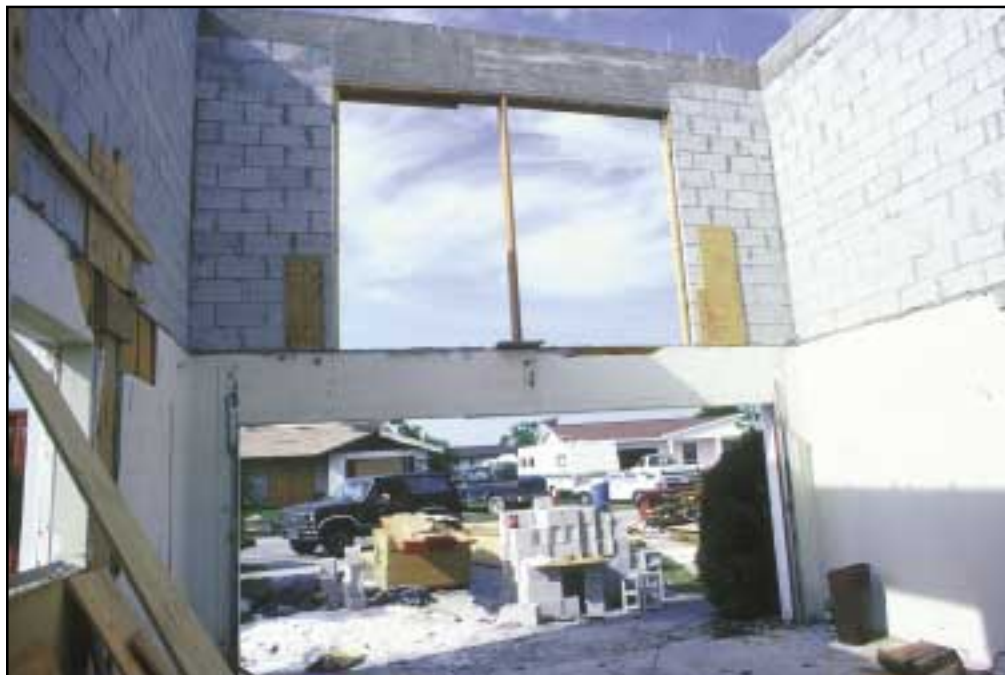
**Figure 66**

The new second-story walls as seen from inside the garage.

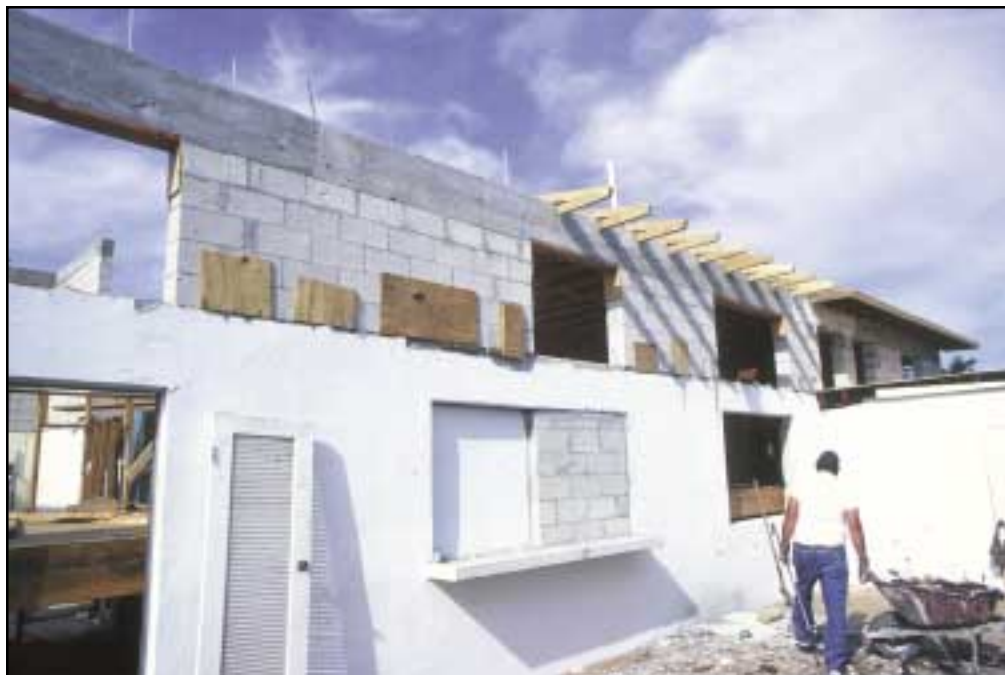
**Figure 67**

The extended first-story walls.

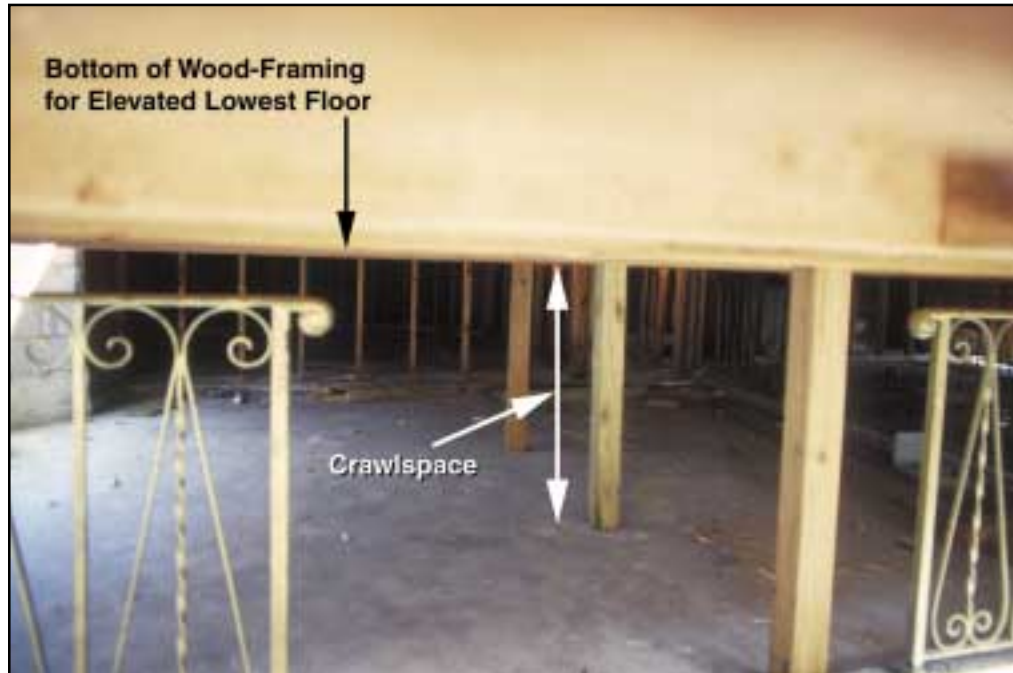
**Figure 68**

Rather than install a new concrete slab on compacted fill, the owner of this house chose to build a new wood-frame floor above the old concrete slab. This method creates a crawlspace below the new floor.

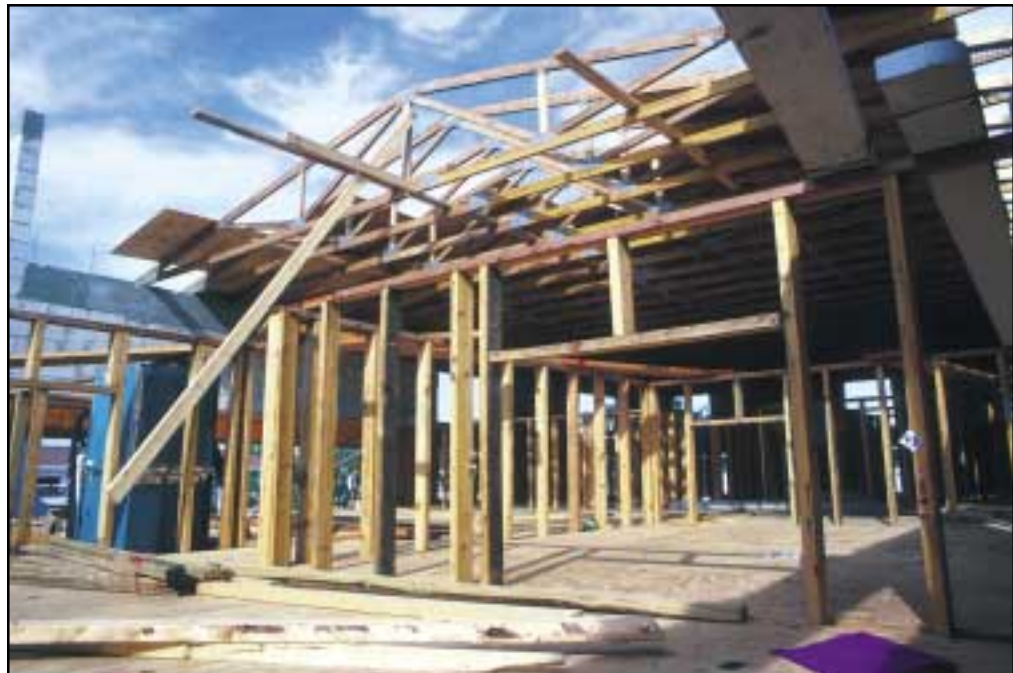
**Figure 69**

Wood framing is used for the new second story.

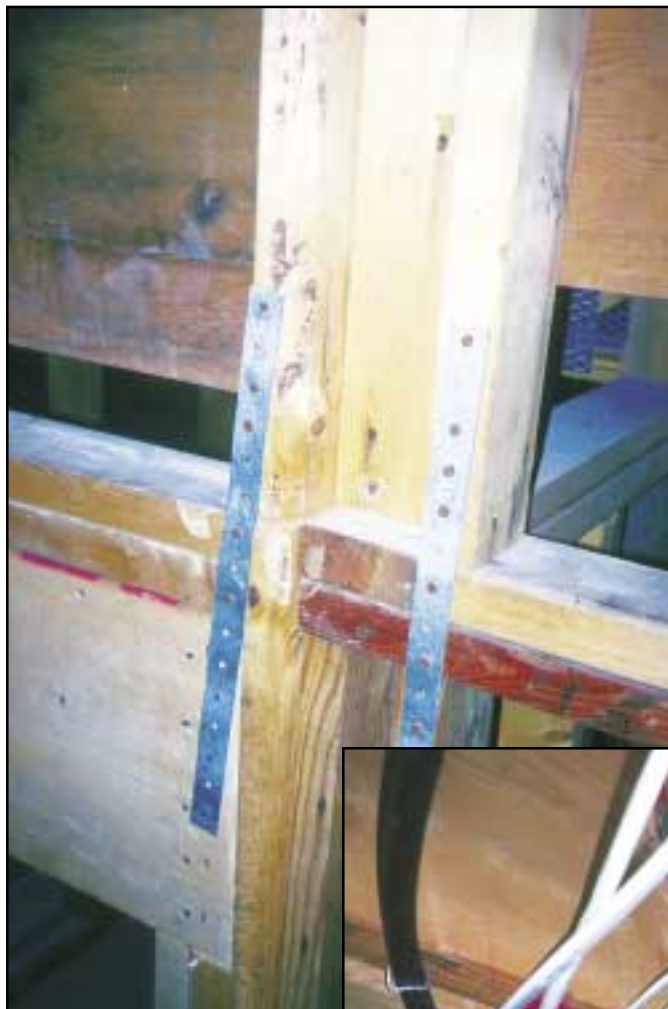
**Figure 70**

Metal hurricane straps are used to tie the structural members together and create a continuous load path from the roof to the foundation.

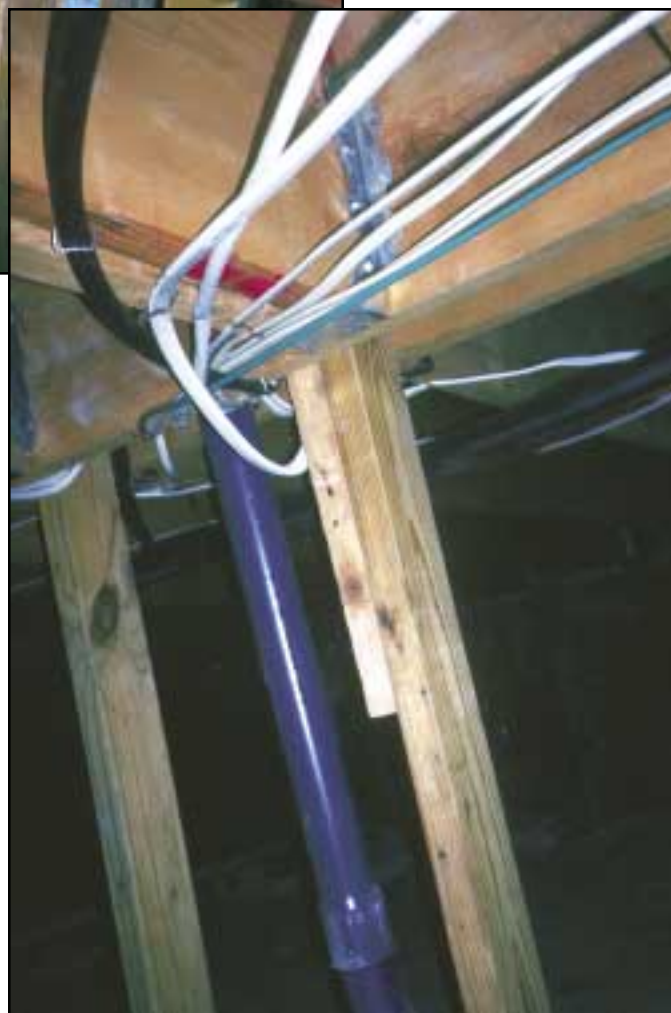
**Figure 71**

All plumbing and electrical renovation work must be performed according to state and local code requirements.

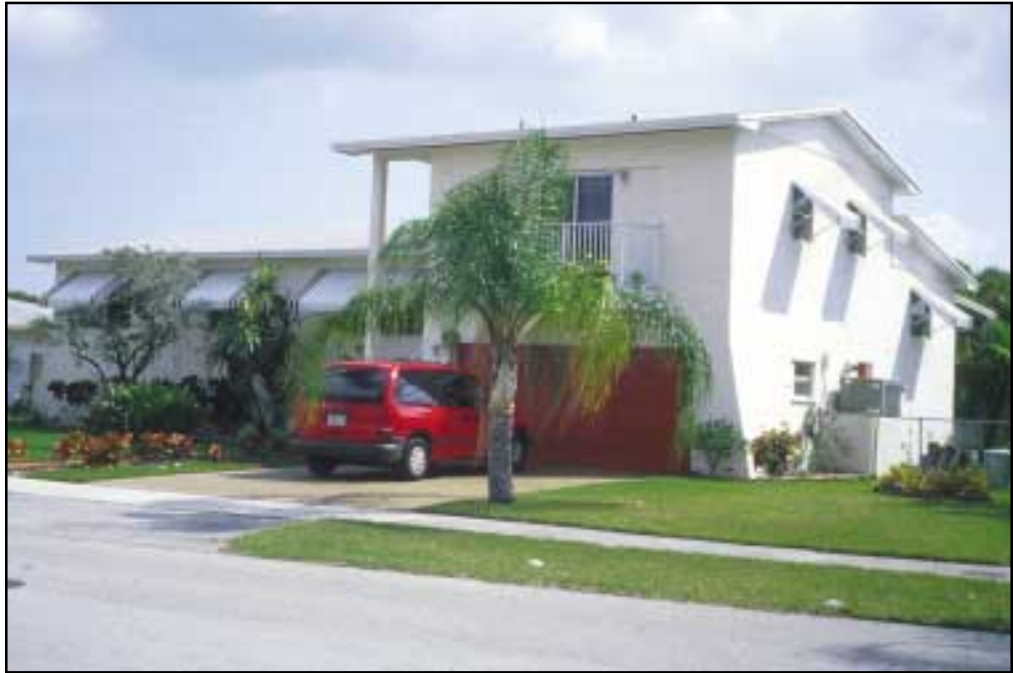
**Figure 72**

The completed house is compliant with local floodplain management requirements, is more resistant to flood damage, and provides additional living area above the flood level.
