FEDERAL EMERGENCY MANAGEMENT AGENCY

# *Above the Flood:* **ELEVATING YOUR FLOODPRONE HOUSE**

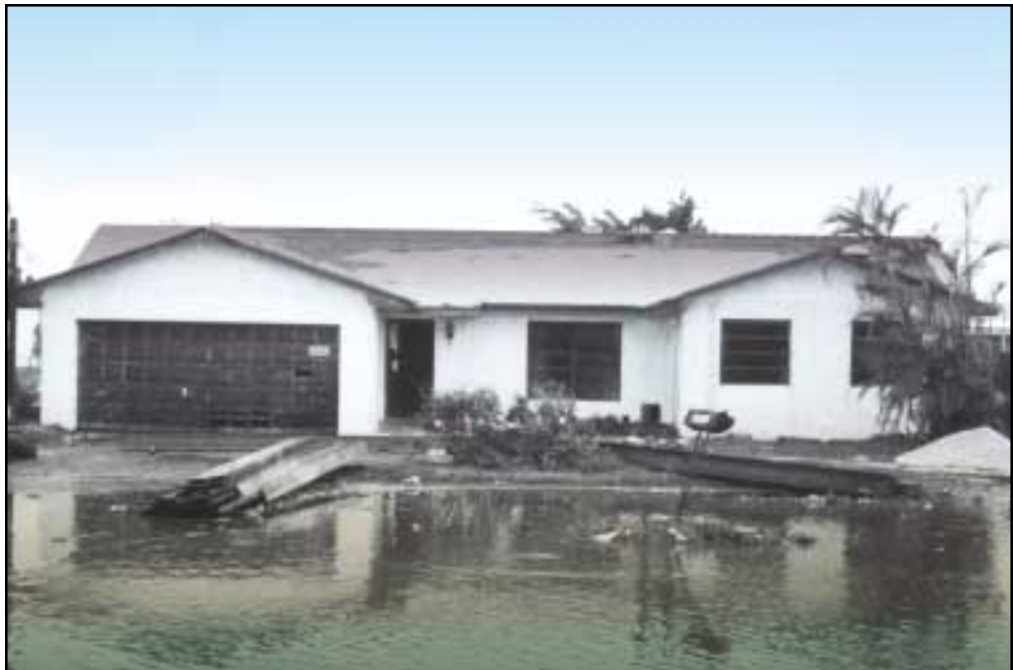
**Figure 73**

Like the houses shown previously, this one-story house, with its concrete block walls, concrete slab foundation, and attached garage, is typical of the houses in the area affected by Hurricane Andrew.

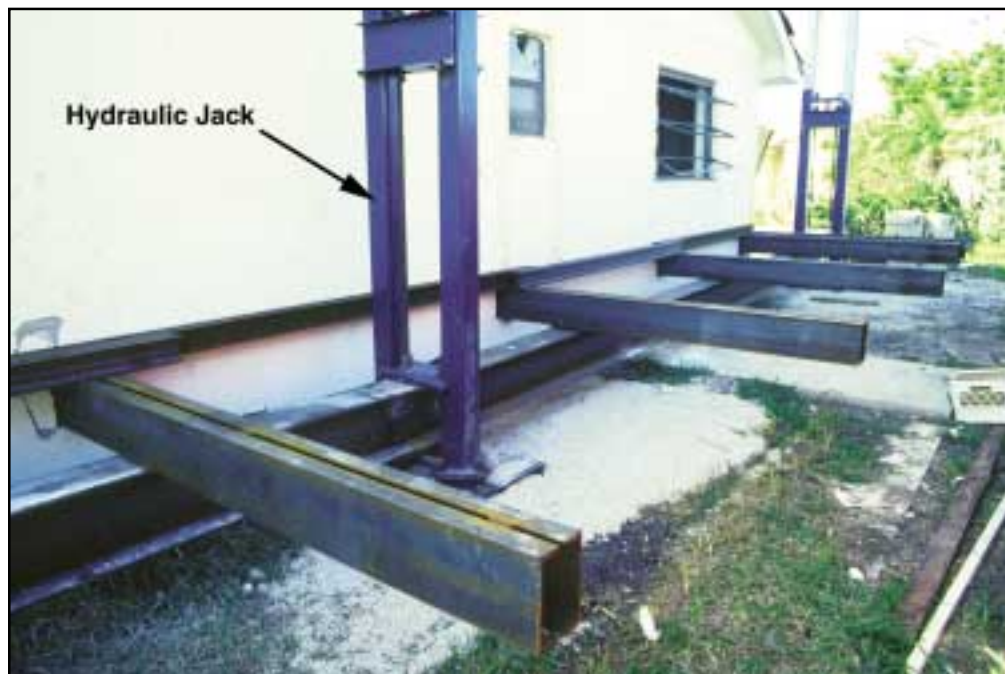
**Figure 74**

In this variation of Technique 3, steel beams are inserted through the walls of the house rather than under the slab. The beams span the length and width of the house and cross one another inside to create a grid. Outside the house, the beams rest on larger beams that will be raised with hydraulic jacks.

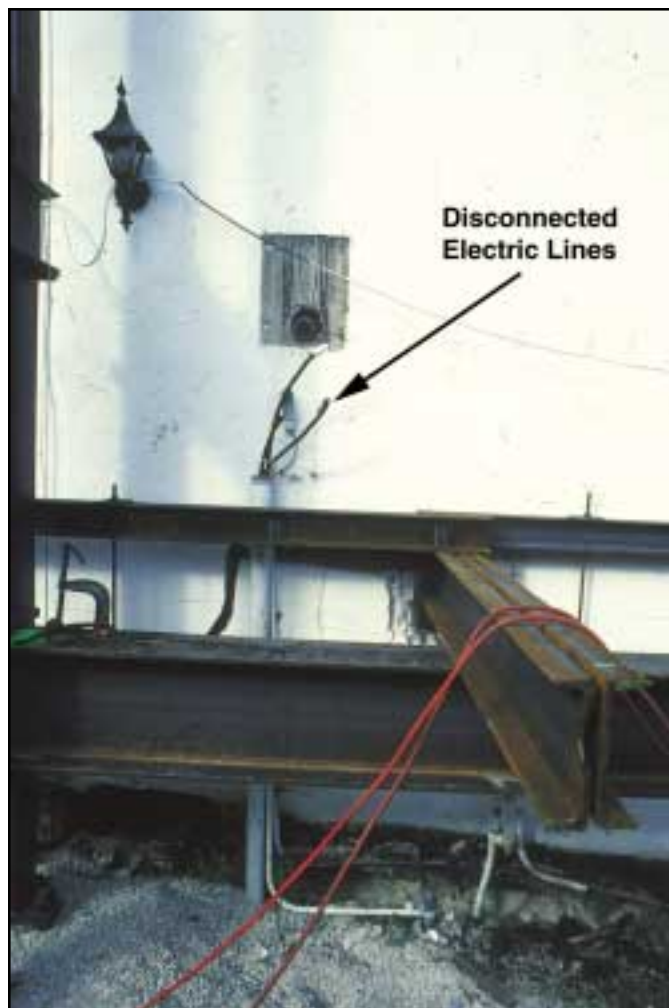
**Figure 75**

Electrical lines and other utilities were disconnected early in the project.

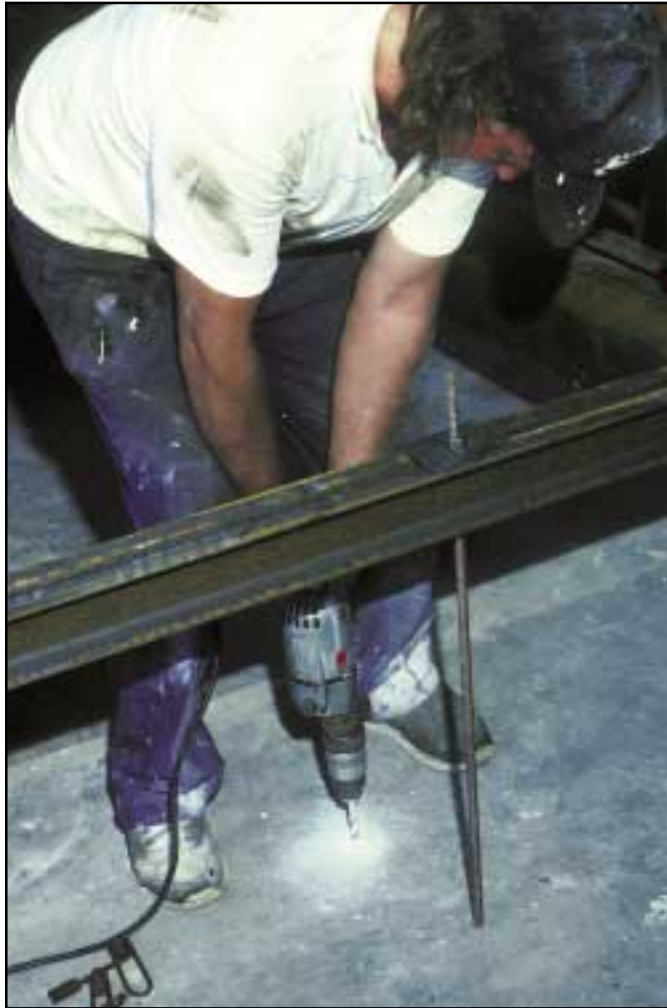
**Figure 76**

Inside the house,  
workers drill holes in  
the concrete slab ...

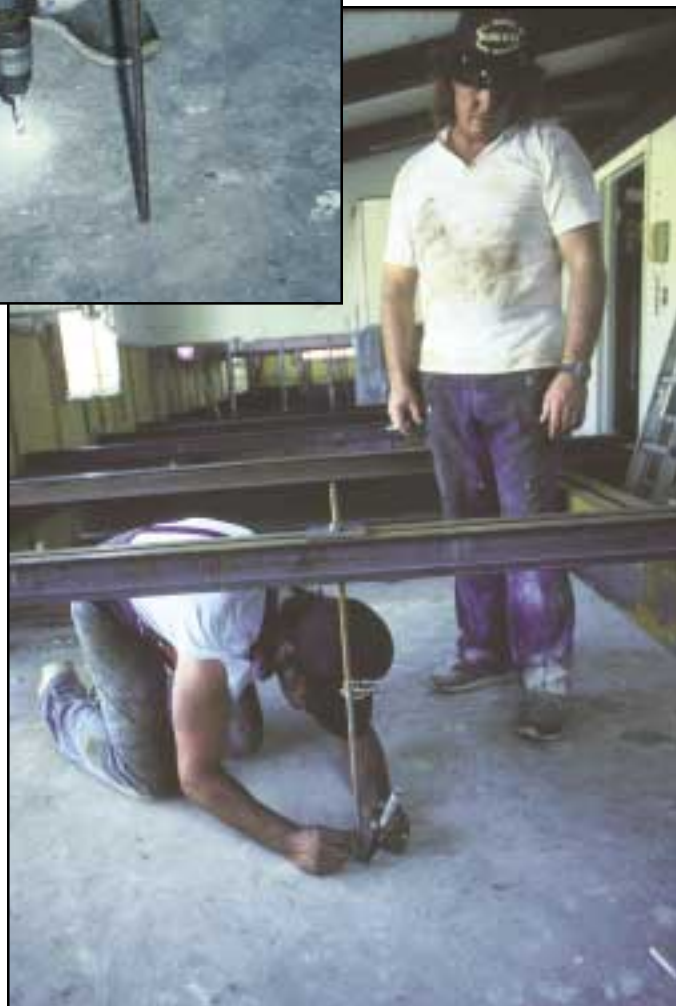
**Figure 77**

... install anchors ...

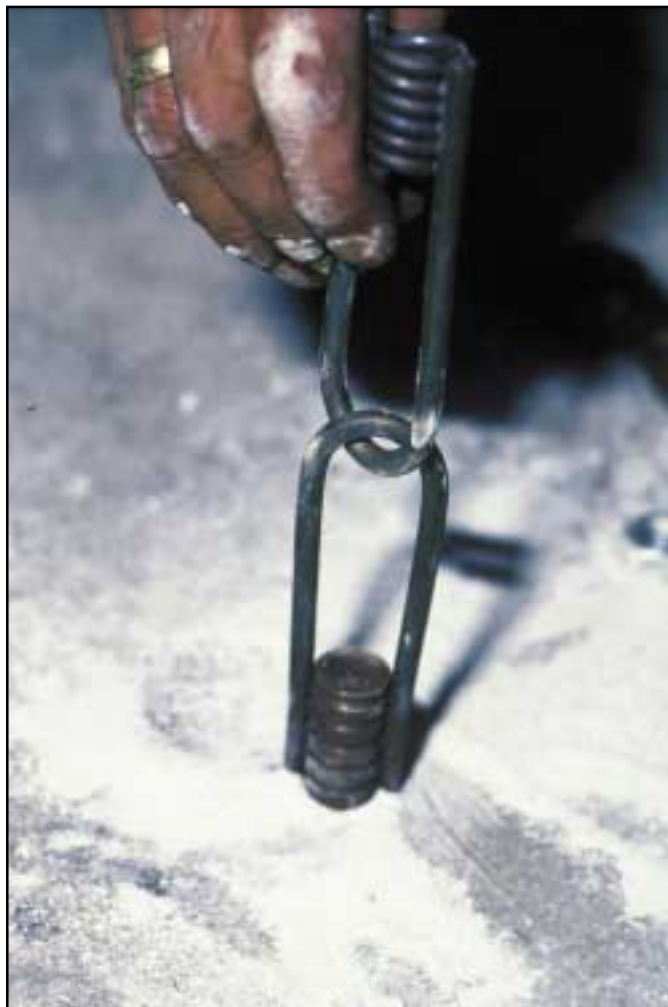
**Figure 78**

... and use hangers to attach the anchors to the grid of steel beams.

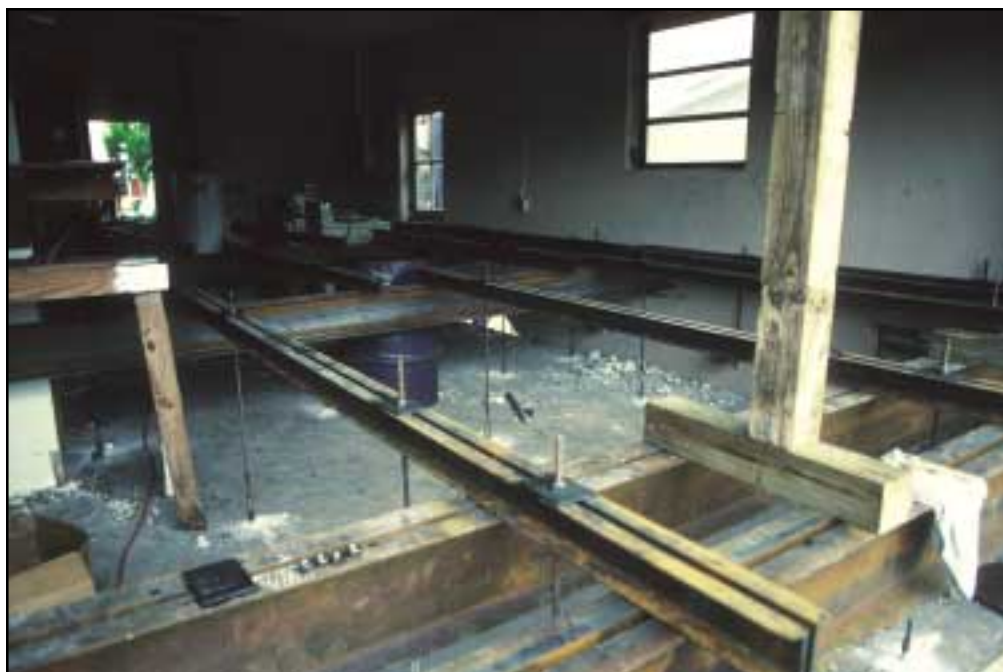
**Figure 79**

The anchors and hangers connect the slab securely to the beams, enabling the beams to raise the slab along with the rest of the house.

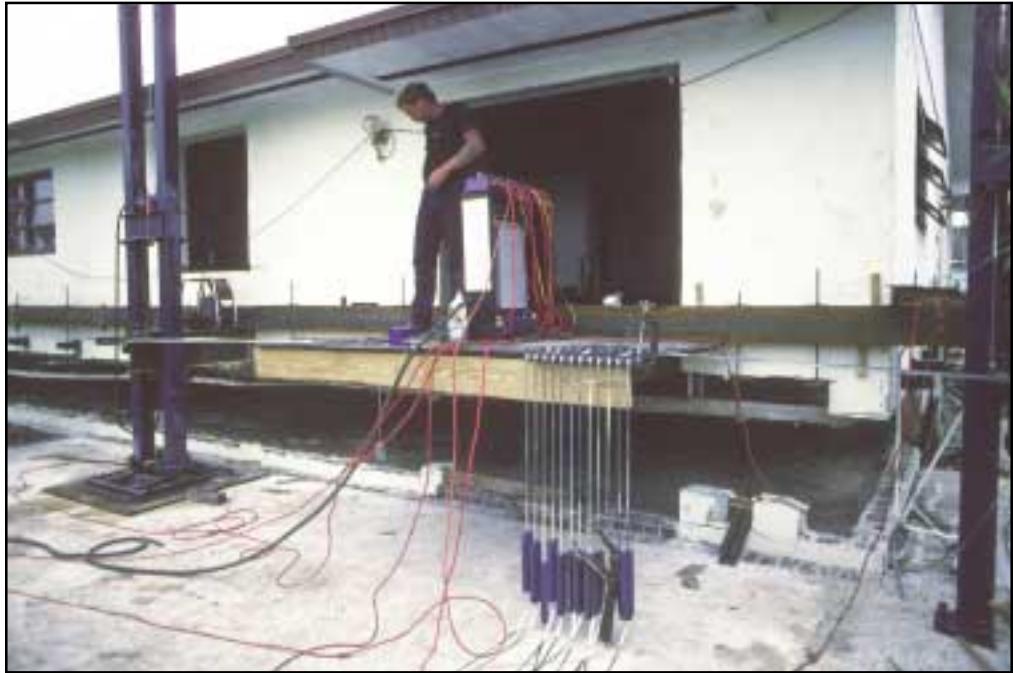
**Figure 80**

Lifting the house, while simple in theory, is complicated by the need to ensure an equal amount of lift at each jack throughout the process. Too much or too little lift at even one jack can cause the slab and walls to crack. The elevation contractor for this project used a sophisticated jacking system that provided the required level of control.

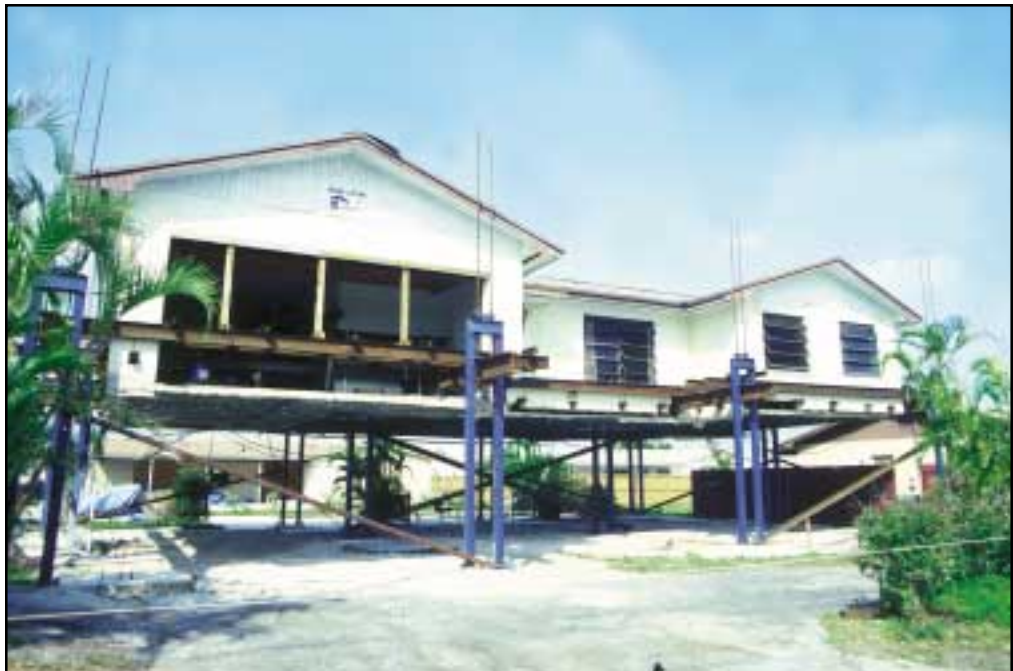
**Figure 81**

The house and slab were raised one full story.

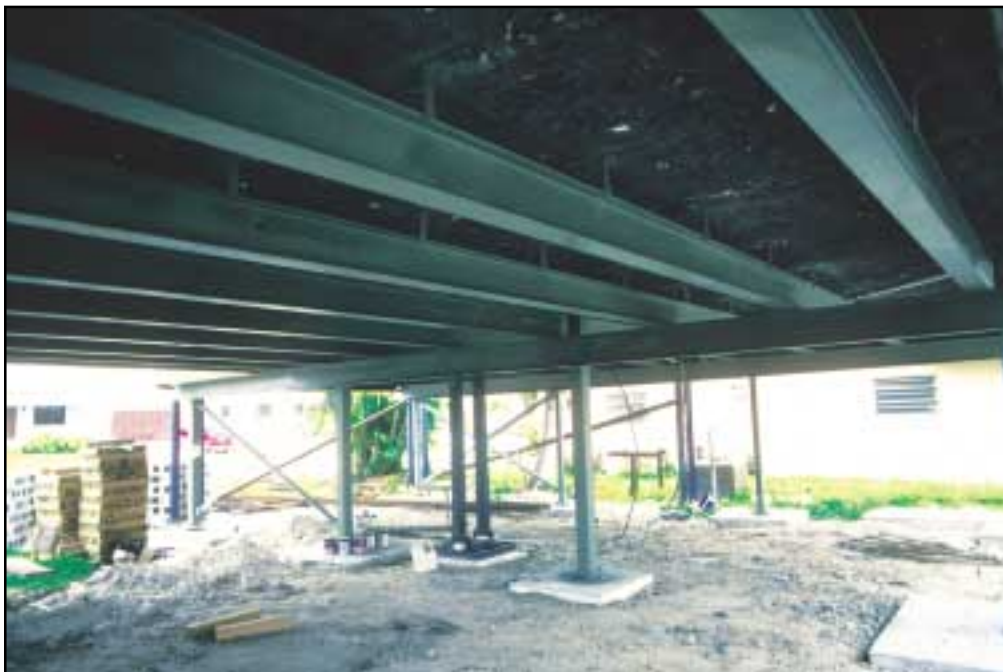
**Figure 82**

While the jacks and beams supported the house, new steel foundation members were installed below.

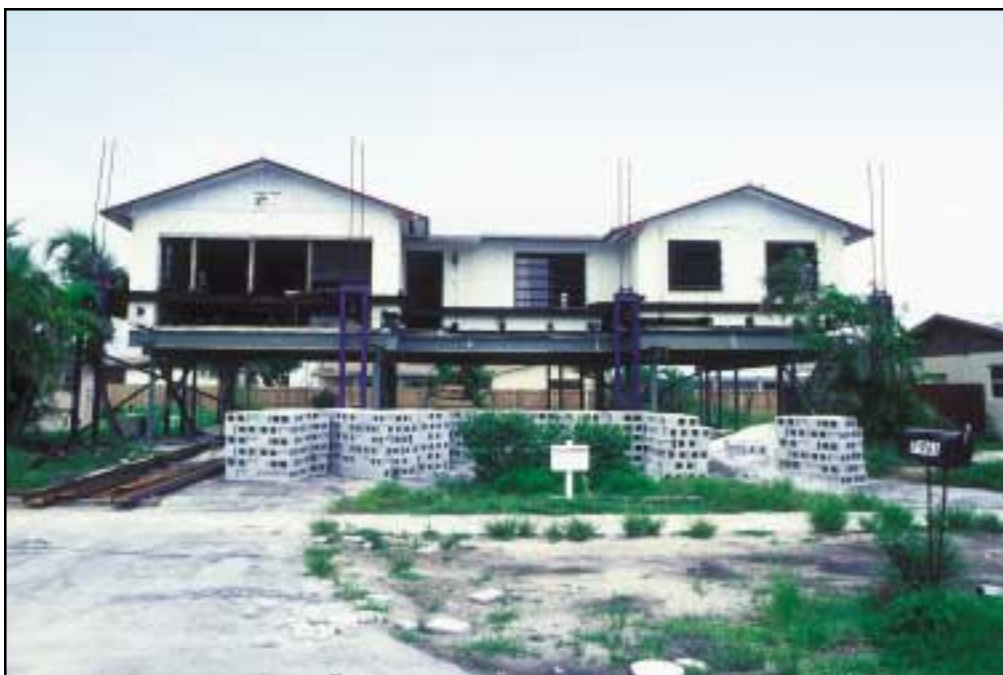
**Figure 83**

Concrete blocks were brought to the site ...

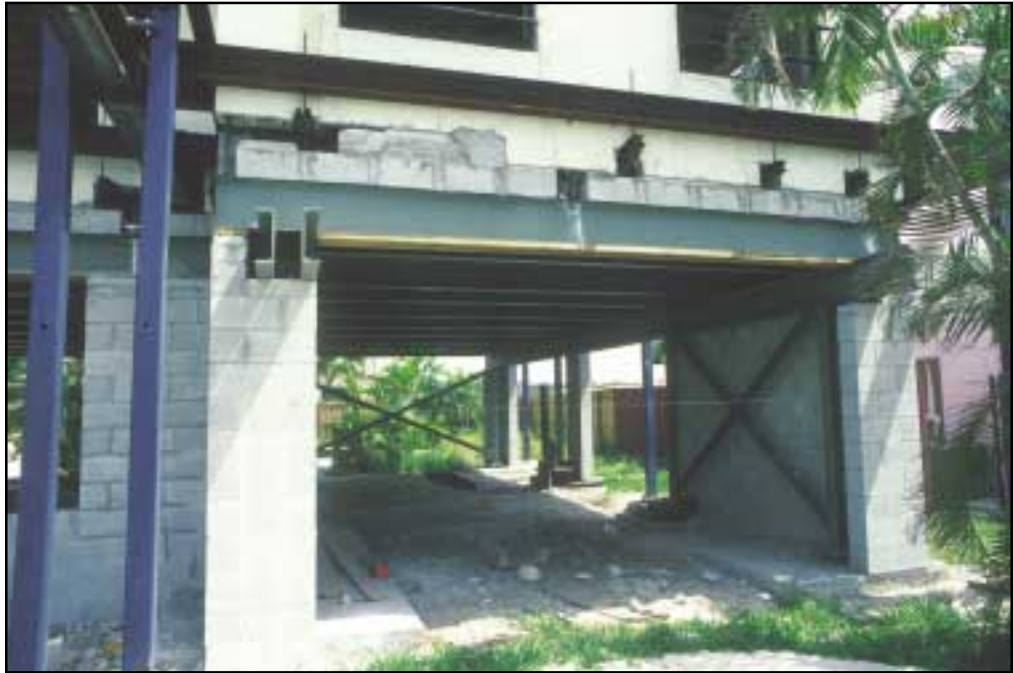
**Figure 84**

... and used to build the lower-level walls.

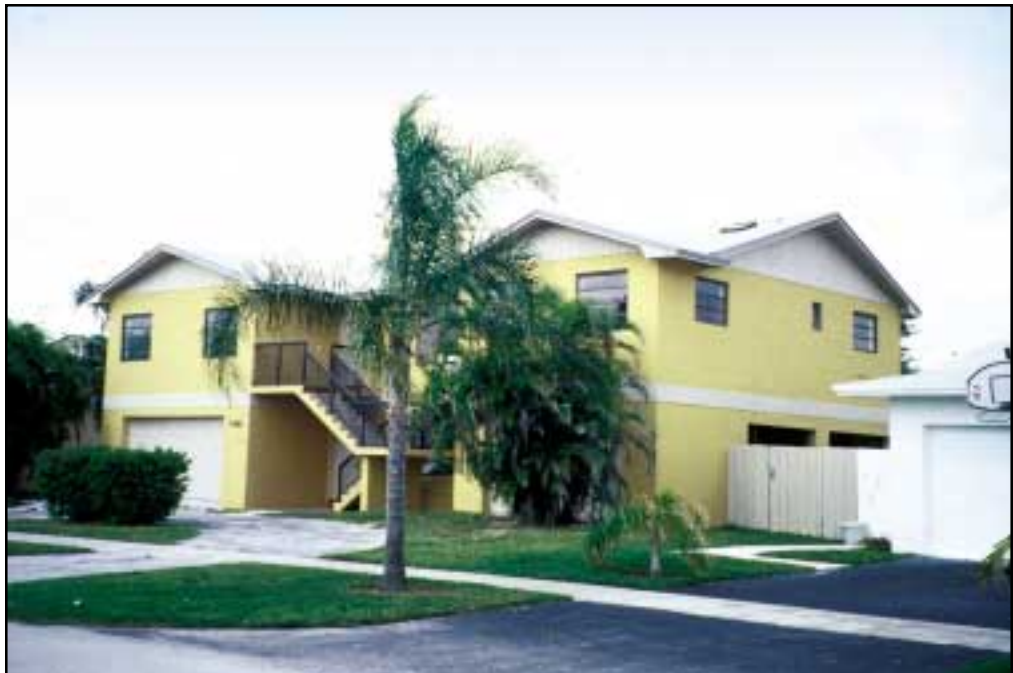
**Figure 85**

The completed house, with lower-level space for parking and storage and upper-level living space, looks as if it were originally designed and built as a two-story structure.
